HISTORIC RESOURCES INVENTORY FORM
For Buildings and Structures

- 1. BUILDING NAME: Common: _____ Historic: Mission Chapel
- 2. TOWN/CITY: Middletown VILLAGE: _____ COUNTY: Middlesex
- 3. STREET & NUMBER (and/or location): 9-11 Liberty Street
- 4. OWNER(S): Sebastian G. Mazzotta PUBLIC PRIVATE
- 5. USE: Present: Double Residence Historic: Methodist Chapel
- 6. ACCESSIBILITY TO PUBLIC: Exterior visible from public road: yes no
Interior accessible: yes, explain with tenant's permission no

Mission Chapel
9-11 Liberty Street, Middletown, CT 06457

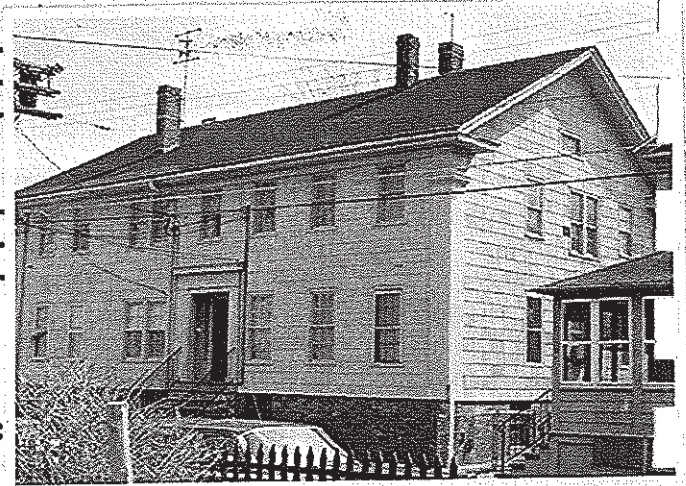
photographer: Roger Sherman
date: 5/78 view: southwest
negative on file: Roll 17, #26A

- 13. INTEGRITY: Location: on original site Interior now apartments; original pillars on east
Alterations: no yes, explain: end removed, east entrance closed
