HISTORIC RESOURCES INVENTORY FORM
For Buildings and Structures

- BUILDING NAME: Common: St. John's Parochial School Historic: same
- TOWN/CITY: Middletown VILLAGE: _____ COUNTY: Middlesex
- STREET & NUMBER (and/or location): 5 St. John's Square
- OWNER(S): Diocese of Norwich PUBLIC PRIVATE
- USE: Present: Educational Historic: same
- ACCESSIBILITY TO PUBLIC: Exterior visible from public road: yes no
Interior accessible: yes, explain during school hours no

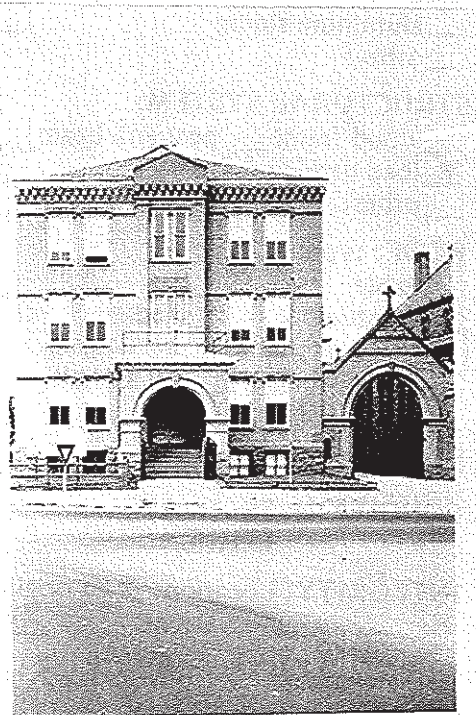
photographer: Roger Sherman
date: 10/78 view: south
negative on file: Roll 43, #3

The current school building was erected in 1887 and blessed in 1888. It is a sturdy rectangular 3½-story structure built of red brick with a cut brownstone foundation and slate roof. A one-story arched entrance porch dignifies the facade. A small front "schoolhouse" belfry has been replaced by a raised central gable and cross. This change, and the installation of interior wiring and plumbing around 1900, are virtually the only alterations.
