CONNECTICUT HISTORICAL COMMISSION

HISTORIC RESOURCES INVENTORY FORM

- 1. BUILDING NAME: Common: Hubbard Estate Historic: Wilcox-Meech House
- 2. TOWN/CITY: Middletown VILLAGE: _____ COUNTY: Middlesex
- 3. STREET & NUMBER (and/or location): 55 Crescent Street
- 4. OWNER(S): Middlesex Memorial Hospital PUBLIC PRIVATE
- 5. USE: Present: Offices Historic: Double Residence
- 6. ACCESSIBILITY TO PUBLIC: Exterior visible from public road: yes no
Interior accessible: yes, explain _____ no

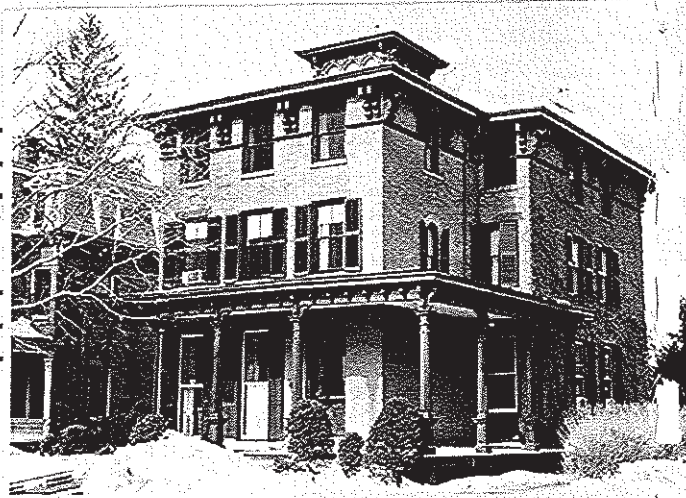
PHOTOGRAPH

The building displays the rich detail typical of Crescent Street in the 1870's: a later but complementary veranda, original shutters, brownstone sills, lintels and foundation, and paired brackets supporting the eaves. A high style cupola has rounded windows, similar decorative detail and a finial. The fine interior is in virtually original condition.

photographer: Elizabeth Loomis
 date: 2/78 view: southeast
 negative on file: Roll 15, #4
