HISTORIC RESOURCES INVENTORY FORM
For Buildings and Structures

- 1. BUILDING NAME: Common: Crescent Street Row Houses Historic: Hotchkiss Block
- 2. TOWN/CITY: Middletown VILLAGE: _____ COUNTY: Middlesex
- 3. STREET & NUMBER (and/or location): 71-83 Crescent Street
- 4. OWNER(S): Eva Loffredo et al. PUBLIC PRIVATE
- 5. USE: Present: Offices & residential Historic: Residential - Apartments
- 6. ACCESSIBILITY TO PUBLIC: Exterior visible from public road: yes no
Interior accessible: yes, explain with tenant's permission no

Hotchkiss Block
71-83 Crescent Street, Middletown, Ct. 06457

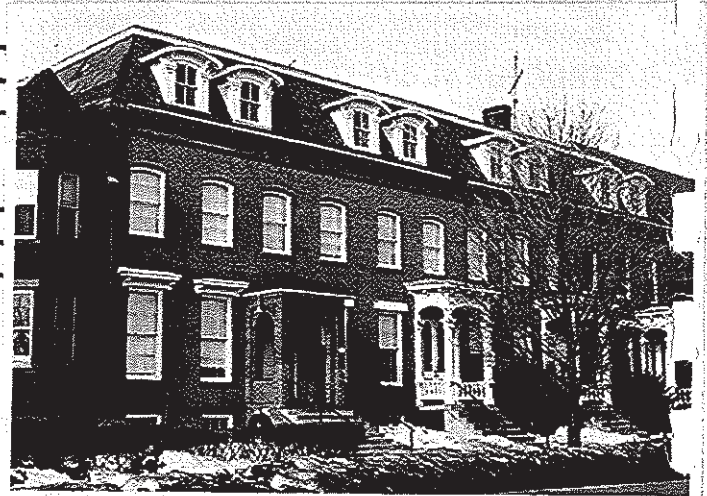
photographer: Elizabeth Loomis
date: 2/78 view: southeast
negative on file: Roll 14, #30A

Additional significance lies in the architectural character of the buildings. They prominently display the decorative elements of the Second Empire style: dormers; decorative lintels, and high style entranceways. These features, recently painted white, accent the scrubbed brick facade. Most of the units have been converted to office use; some still
