HISTORIC RESOURCES INVENTORY FORM  
For Buildings and Structures

- 1. BUILDING NAME: Common: Alsop Farmhouse Historic: Joseph Wright, Jr. House
- 2. TOWN/CITY: Middletown VILLAGE: \_\_\_\_\_ COUNTY: Middlesex
- 3. STREET & NUMBER (and/or location): 1181 East Street
- 4. OWNER(S): George J. Achenbach PUBLIC  PRIVATE
- 5. USE: Present: Vacant Historic: Residence
- 6. ACCESSIBILITY TO PUBLIC: Exterior visible from public road:  yes  no  
Interior accessible:  yes, explain \_\_\_\_\_  no

- 7. STYLE OF BUILDING: Center-Chimney Colonial DATE OF CONSTRUCTION: c. 1735-1740
- 8. MATERIAL(S) (indicate use or location when appropriate):

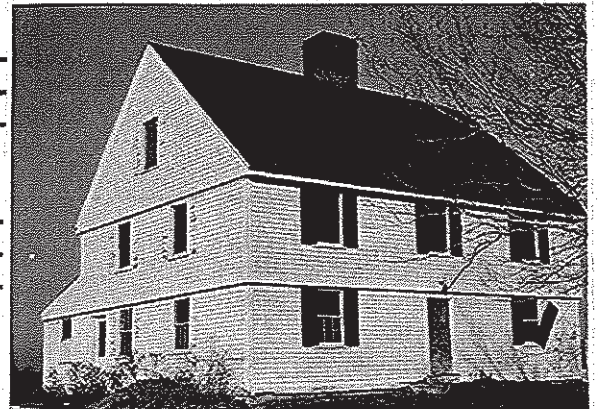
photographer: John E. Reynolds  
date: 12/78 view: southeast  
negative on file: Roll 51, #35

The Wright House in Westfield, although presently vacant and suffering from neglect, retains most of its original fabric and decoration. This includes hardware, raised paneling, fireplaces, and a fine triple-run staircase. Reflecting Wright's elevated standing in Colonial Middletown, his house displays an elaborate and formal decorative treatment which belies its early date and rural origin.

none known  highways  vandalism  developers  other: \_\_\_\_\_  
 renewal  private  deterioration  zoning  explanation: building is vacant, without maintenance and is vulnerable to vandalism
