HISTORIC RESOURCES INVENTORY FORM

- 1. BUILDING NAME: Common: Master Supply Historic: Hotchkiss Block
- 2. TOWN/CITY: Middletown VILLAGE: _____ COUNTY: Middletown
- 3. STREET & NUMBER (and/or location): 598-614 Main Street
- 4. OWNER(S): Jacob Levine PUBLIC PRIVATE
- 5. USE: Present: Commercial & residential Historic: same
- 6. ACCESSIBILITY TO PUBLIC: Exterior visible from public road: yes no
Interior accessible: yes, explain store no

Hotchkiss Block
598-614 Main Street, Middletown, CT 06457

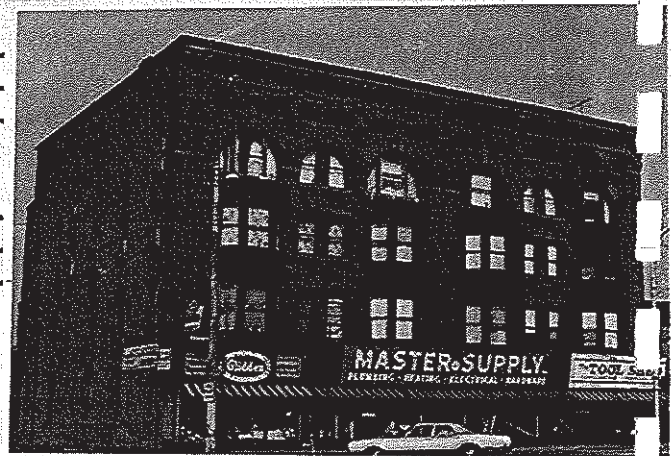
PHOTOGRAPH

Pressed copper sheathing on cornice, bay windows, and sign panel above storefronts.

This large commercial and residential building, more than eighty feet on a side and four stories high, looms over nearby structures from its corner site and reflects the massive bulk of the Arrawani Hotel across the street. It features a six-bay facade with Renaissance Revival elements. The cornice is supported by paired brackets; raised ornamental brickwork highlights the wall below the cornice; bay windows adorn four of the six bays. The cornice, bay windows, and sign panel are clad in pressed metal. There are still twelve apartments above the stores on the ground level as in 1894. This important commercial building continues its appearance and function largely intact after the better part of a century.

photographer: Elizabeth Loomis
date: 5/78 view: northeast
negative on file: Roll 25A, #27
