OF CONNECTICUT
CUT HISTORICAL COMMISSION
 Prospect Street, Hartford, Connecticut 06106
 861-3005
RESOURCES INVENTORY FORM
 Buildings and Structures

BUILDING NAME: Common: _____ Historic: Samuel Harris House

ADDRESS & NUMBER (and/or location): 612 Middle Street

STYLE OF BUILDING: Center-Chimney Saltbox DATE OF CONSTRUCTION: c. 1686

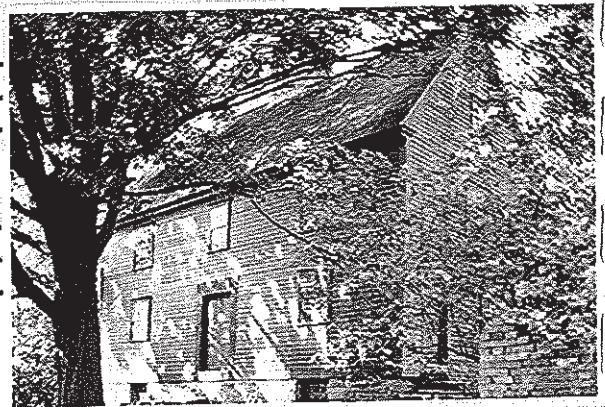
PHOTOGRAPH

This house features a three-bay facade with small sash windows; a double leaf entrance door; and cellar windows in the high brownstone foundation. The slope of the roofline in the rear clearly defines the lean-to addition. Through its long history and present faithful restoration this house presents the most complete picture of 17th century architecture in Middletown.

photographer: John E. Reynolds
date: 9/78 view: northeast
negative on file: Roll 31, #3
