HISTORIC RESOURCES INVENTORY FORM
For Buildings and Structures

- 1. BUILDING NAME: Common: _____ Historic: John Loveland House
- 2. TOWN/CITY: Middletown VILLAGE: _____ COUNTY: Middlesex
- 3. STREET & NUMBER (and/or location): 133 South Main Street
- 4. OWNER(S): Naomi A. Woodmore PUBLIC PRIVATE
- 5. USE: Present: Residence Historic: same
- 6. ACCESSIBILITY TO PUBLIC: Exterior visible from public road: yes no
Interior accessible: yes, explain with permission no

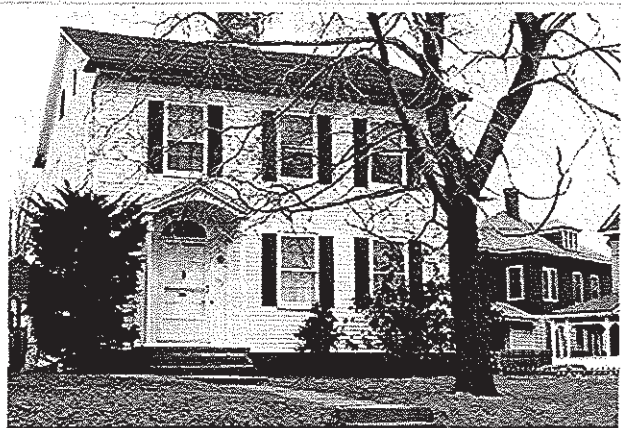
PHOTOGRAPH

- Leaded fanlight over door
- Modillioned cornice
- Quarter round fanlights in gables

The three-bay, side hall, ridge-to-street configuration of this house was a prevalent form of house construction in Middletown during the early nineteenth century. Federal details such as the leaded fanlight over the door and a modillioned cornice remain; however, full height fluted corner pilasters were removed sometime after 1935.

photographer: Elizabeth Loomis
date: 4/78 view: east
negative on file: Roll 18, 12A
