HISTORIC RESOURCES INVENTORY FORM
For Buildings and Structures

- 1. BUILDING NAME: Common: _____ Historic: _____
- 2. TOWN/CITY: Middletown 348 Bartholomew Road (A), COUNTY: Middlesex
- 3. STREET & NUMBER (and/or location): and two houses north side of Bow Lane (B&C) see cont. sheet
- 4. OWNER(S): See next page (below #21) _____ PUBLIC PRIVATE
- 5. USE: Present: Residential Historic: same
- 6. ACCESSIBILITY TO PUBLIC: Exterior visible from public road: yes no
Interior accessible: yes, explain _____ no

7. STYLE OF BUILDING: Center-Chimney Colonial DATE OF CONSTRUCTION: Late 18th C.

348 Bartholomew Road and two houses north side
of Bow Lane, Middletown, Ct. 06457

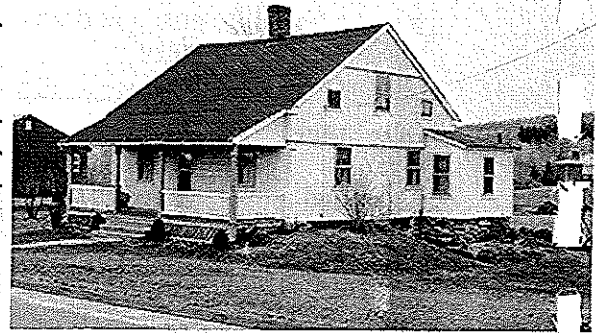
A

photographer: Robert Svec
date: 12/78 view: A: sw; B: south; C: south
negative on file: A: Roll 52, #29A; B: Roll 55, #21A;
C: Roll 55, #24-24A

- A: 348 Bartholomew Road
- B: Bow Lane; north side, .2 miles west of Bartholomew Road
- C: Bow Lane; north side, .1 mile east of Bartholomew Road

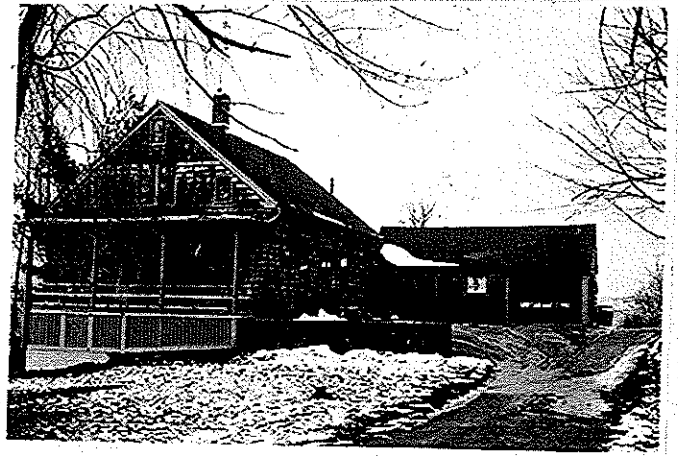
- 14. RELATED OUTBUILDINGS OR LANDSCAPE FEATURES:
 barn shed C: garage other landscape features or buildings: brownstone retaining wall borders front of C
 carriage house shop garden
