HISTORIC RESOURCES INVENTORY FORM
For Buildings and Structures

- 1. BUILDING NAME: Common: _____ Historic: "The White Rock"
- 2. TOWN/CITY: Middletown VILLAGE: _____ COUNTY: Middlesex
- 3. STREET & NUMBER (and/or location): 628-630 Bow Lane
- 4. OWNER(S): Anthony and Lillian Kriwokulski PUBLIC PRIVATE
- 5. USE: Present: Residential (multiple) Historic: Residence
- 6. ACCESSIBILITY TO PUBLIC: Exterior visible from public road: yes no
Interior accessible: yes, explain _____ no

"The White Rock"
628-630 Bow Lane, Middletown, Ct. 06457

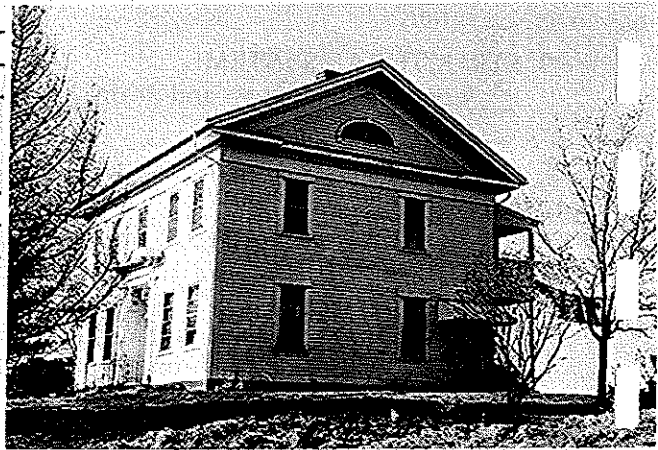
PHOTOGRAPH

- 11. NUMBER OF STORIES: 2½ APPROXIMATE DIMENSIONS: 32'x31'; addition 21'x29'
- 12. CONDITION: Structural: ___ excellent good ___ fair ___ deteriorated
Exterior: ___ excellent good ___ fair ___ deteriorated

- 13. INTEGRITY: Location: on original site ___ moved, when: _____
Alterations: ___ no yes, explain: Early west wing with enclosed front porch added;
- 14. RELATED OUTBUILDINGS OR LANDSCAPE FEATURES: Victorian remodelling (see #18)
___ barn ___ shed ___ garage ___ other landscape features or buildings: _____
___ carriage house ___ shop ___ garden

The building has a large rectangular profile that is emphasized by its wide five-bay facade. The ridge of the gabled roof runs parallel to the street, and is capped by two chimneys set to either side. Beneath the gables, fanlights are displayed. These features, indicative of the Federal style, suggest the building's early origin. It also exhibits Victorian decoration that was probably applied during the late 1800s. Deep pediments project from the gables and the eaves are bordered by plain, wide fascia boards and large dentils. The main entrance displays fluted pilasters that support a prominent entablature. Scroll brackets are displayed beneath the cornice and above the recessed, double doors.

photographer: Robert Svec
date: 12/78 view: south and east
negative on file: Roll 53, #32 & 37
