HISTORIC RESOURCES INVENTORY FORM

- 1. BUILDING NAME: Common: _____ Historic: David Tryon House
- 2. TOWN/CITY: Middletown VILLAGE: _____ COUNTY: Middlesex
- 3. STREET & NUMBER (and/or location): 655 Bow Lane
- 4. OWNER(S): Krishna Winston & Donald Billingsley PUBLIC PRIVATE
- 5. USE: Present: Residence Historic: same
- 6. ACCESSIBILITY TO PUBLIC: Exterior visible from public road: yes no
Interior accessible: yes, explain with permission no

Center-Chimney Colonial

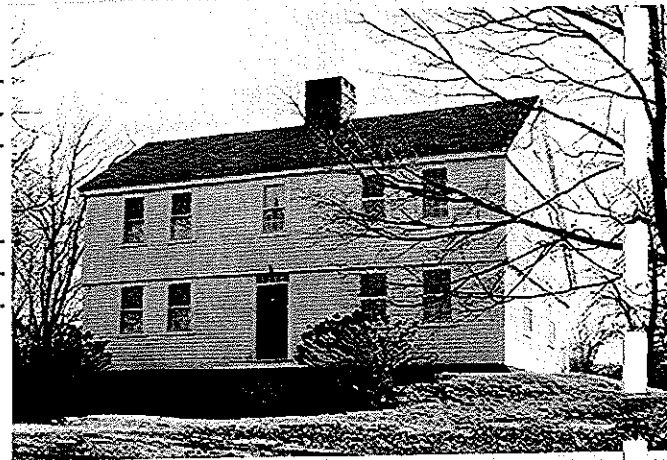
photographer: Robert Svec
date: 12/78 view: north
negative on file: Roll 55, #3

12. CONDITION: Structural: ___ excellent good ___ fair ___ deteriorated
Exterior: ___ excellent good ___ fair ___ deteriorated

13. INTEGRITY: Location: on original site ___ moved, when: _____
Alterations: no yes, explain: Rear porch added

The house exhibits a building style popular in Middletown during the eighteenth century. The broad roof, crowned by a large center chimney, pitches to the first story in the rear, and forms a saltbox configuration. The three-bay facade has a central entrance that displays five rectangular lights above the door. Double overhangs decorate the clapboarded walls.
