HISTORIC RESOURCES INVENTORY FORM

39-41: Buckley Hedges House

1. BUILDING NAME: Common: \_\_\_\_\_ Historic: 51: J.P. Davis House

3. STREET & NUMBER (and/or location): 39-41 and 51 Bretton Road

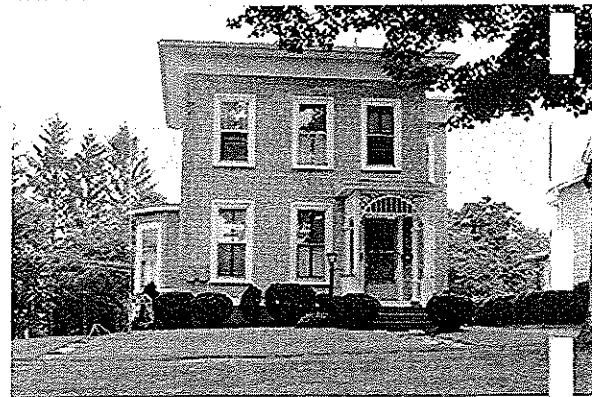
39 Bretton Road

These two structures are of the Italianate style. They both display the typical features of that style: flat roof, wide eaves, decorative entrance porches, and bay windows. 39-41 Bretton Road, built on a large scale, retains its original clapboards, decorative wooden sills and lintels, and brackets under the eaves. 51 Bretton Road is smaller and displays delicate stickwork in its entranceway and east veranda. They are illustrative of the expansion of residential areas outside of the center of Middletown after the Civil War.
