HISTORIC RESOURCES INVENTORY FORM
For Buildings and Structures

- 1. BUILDING NAME: Common: _____ Historic: William Trench House
- 2. TOWN/CITY: Middletown VILLAGE: _____ COUNTY: Middlesex
- 3. STREET & NUMBER (and/or location): 31 Broad Street
- 4. OWNER(S): Marie Francis Daly PUBLIC PRIVATE
- 5. USE: Present: Residence Historic: same
- 6. ACCESSIBILITY TO PUBLIC: Exterior visible from public road: yes no
Interior accessible: yes, explain with occupant's permission no

William Trench House
31 Broad Street, Middletown, CT 06457

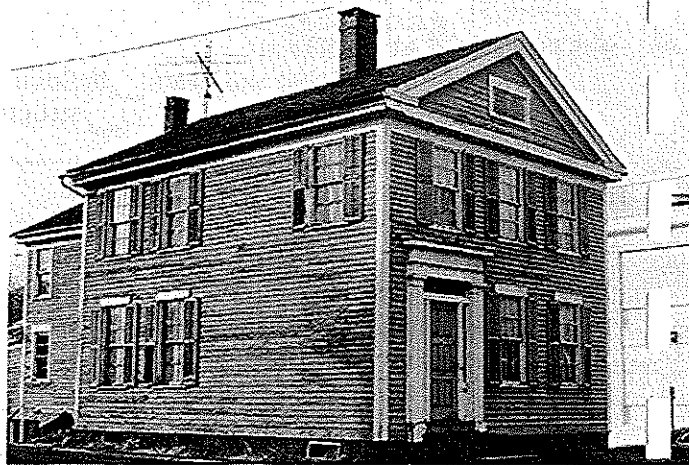
PHOTOGRAPH

This is a good example of the popular three-bay Greek Revival house with pedimented gable to the street. It retains many original features—clapboards, decorative details, doorway with transom and sidelights, early shutters, and original kitchen wing. This is the only early nineteenth century domestic building remaining in an area greatly altered by urban renewal.

photographer: Roger N. Sherman
date: 12/77 view: southeast
negative on file: Roll 4, 12A
