HISTORIC RESOURCES INVENTORY FORM
for Buildings and Structures

- 1. BUILDING NAME: Common: _____ Historic: Crandall-Cornwell House
- 2. TOWN/CITY: Middletown VILLAGE: _____ COUNTY: Middlesex
- 3. STREET & NUMBER (and/or location): 89-91 Broad Street
- 4. OWNER(S): Sebastian Cannata et al. PUBLIC PRIVATE
- 5. USE: Present: Residence (Double) Historic: same
- 6. ACCESSIBILITY TO PUBLIC: Exterior visible from public road: yes no
Interior accessible: yes, explain _____ no

Crandall-Cornwell House
89-91 Broad Street, Middletown, CT 06457

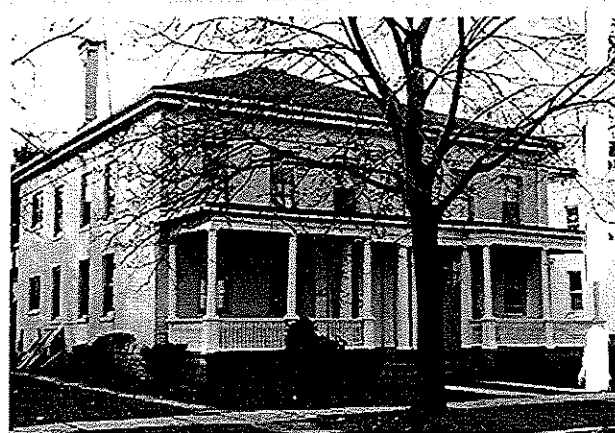
negative on file: Roll 4, #19A

- 13. INTEGRITY: Location: on original site moved, when: _____
Alterations: no yes, explain: West wing added; late 19th century veranda added to entrance porch

Side by side entrances with over and side lights framed by pilasters
Entrance porch with fluted Doric columns expanded to veranda with pedestals
supporting porch roof columns

date: 11/77 view: southeast
