HISTORIC RESOURCES INVENTORY FORM

- 1. BUILDING NAME: Common: American Red Cross Historic: William Hubbard Atkins House
- 2. TOWN/CITY: Middletown VILLAGE: _____ COUNTY: Middlesex
- 3. STREET & NUMBER (and/or location): 93-97 Broad Street
- 4. OWNER(S): American Red Cross PUBLIC PRIVATE
- 5. USE: Present: Offices Historic: Double Residence
- 6. ACCESSIBILITY TO PUBLIC: Exterior visible from public road: xyes no
Interior accessible: xyes, explain office use no

William Atkins House
93-97 Broad Street, Middletown, CT 06457

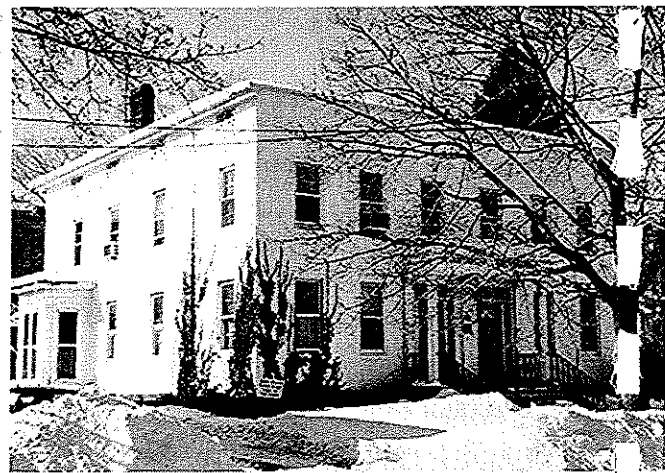
PHOTOGRAPH

- 11. NUMBER OF STORIES: 2 1/2 APPROXIMATE DIMENSIONS: 48'x46'
- 12. CONDITION: Structural: excellent good fair deteriorated
Exterior: excellent good fair deteriorated

- 13. INTEGRITY: Location: on original site Victorian bay window added; center column removed
Alterations: no yes, explain: from front porch; interior altered for office use;

Molded plaster ceilings in north section
Five remaining original fireplaces
Entrance porch with modified Corinthian columns and original details
Attic windows with wooden anthemion motif screens

photographer: Roger N. Sherman
date: 11/77 view: southeast
negative on file: Roll 4, #24A
