HISTORIC RESOURCES INVENTORY FORM
For Buildings and Structures

- 1. BUILDING NAME: Common: Bishop Acheson House Historic: _____
- 2. TOWN/CITY: Middletown VILLAGE: _____ COUNTY: Middlesex
- 3. STREET & NUMBER (and/or location): 144 Broad Street
- 4. OWNER(S): Church of the Holy Trinity PUBLIC PRIVATE
- 5. USE: Present: Rectory Historic: same
- 6. ACCESSIBILITY TO PUBLIC: Exterior visible from public road: yes no
Interior accessible: yes, explain with permission no

Bishop Acheson House
144 Broad Street, Middletown, CT 06457

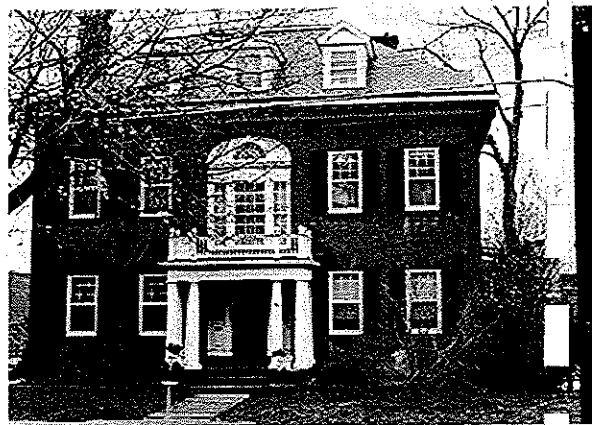
photographer: Roger Sherman
date: 11/77 view: west
negative on file: Roll 3, #4A

This large house is an excellent example of the Georgian Revival style, with well executed details: six column entrance portico with balustrade; Palladian window; and modillioned cornice.
