HISTORIC RESOURCES INVENTORY FORM
For Buildings and Structures

- 1. BUILDING NAME: Common: St. Sebastian Convent Historic: Camp-Stearns-Sheldon House
- 2. TOWN/CITY: Middletown VILLAGE: _____ COUNTY: Middlesex
- 3. STREET & NUMBER (and/or location): 163-165 Broad Street
- 4. OWNER(S): St. Sebastian Church Corporation PUBLIC PRIVATE
- 5. USE: Present: Convent Historic: Double Residence
- 6. ACCESSIBILITY TO PUBLIC: Exterior visible from public road: yes no
Interior accessible: yes, explain _____ no

Camp-Stearns-Sheldon House
163-165 Broad Street, Middletown, CT 06457

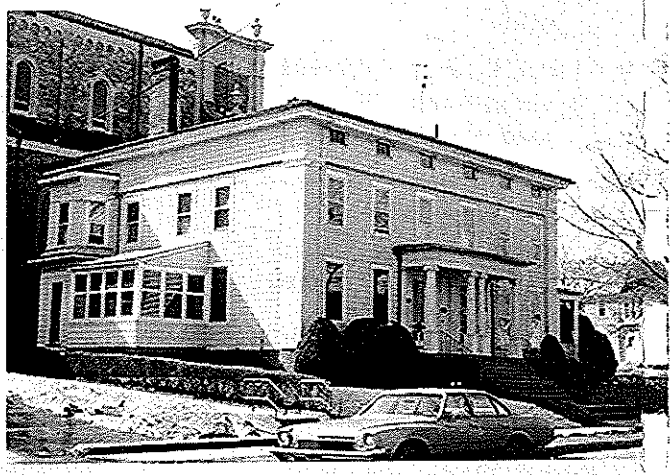
PHOTOGRAPH

This Greek Revival structure's most prominent feature is the heavy columned entrance porch and doors. The building shares characteristics with similar Greek Revival structures on Broad Street: a severe, blocky form, eye brow windows beneath the cornice, corner pilasters, and plain detailing.

photographer: Robert Svec
date: 5/78 view: southeast
negative on file: Roll 20, #6
