HISTORIC RESOURCES INVENTORY FORM

- 1. BUILDING NAME: Common: _____ Historic: William Young House
- 2. TOWN/CITY: Middletown VILLAGE: _____ COUNTY: Middlesex
- 3. STREET & NUMBER (and/or location): Brooks Road; one mile east of Bear Hill Road
- 4. OWNER(S): Catherine Smigel PUBLIC PRIVATE
- 5. USE: Present: Residence Historic: same
- 6. ACCESSIBILITY TO PUBLIC: Exterior visible from public road: yes no
Interior accessible: yes, explain no

- 7. STYLE OF BUILDING: Greek Revival DATE OF CONSTRUCTION: c. 1830
- 8. MATERIAL(S) (indicate use or location when appropriate):
 clapboard facade on west asbestos siding brick
 wood shingle side asphalt siding fieldstone
 board & batten stucco cobblestone
 aluminum siding concrete: type: _____ cut stone: type: granite
 other: _____ foundation

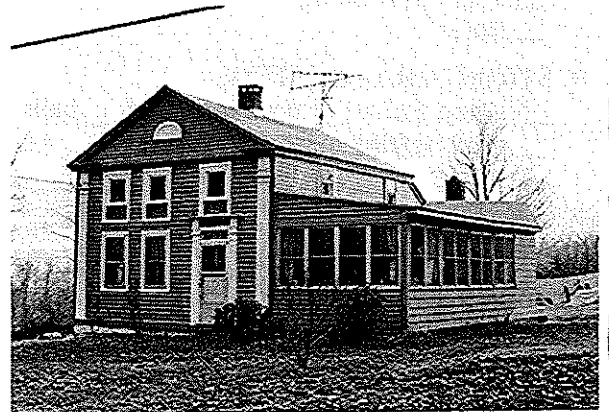
photographer: Robert Svec
date: 12/78 view: north
negative on file: Roll 52, #23A

The structure is of the Greek Revival style. Its three-bay facade displays corner pilasters and the entrance is set to the side. Pilasters supporting a simple entablature frame the entrance, and rectangular lights are above the door. An arched opening, which once held a fanlight, is exhibited in the pediment beneath the gable.
