HISTORIC RESOURCES INVENTORY FORM  
For Buildings and Structures

- 1. BUILDING NAME: Common: Scott Laboratory Historic: same
- 2. TOWN/CITY: Middletown VILLAGE: \_\_\_\_\_ COUNTY: Middlesex
- 3. STREET & NUMBER (and/or location): Church Street
- 4. OWNER(S): Wesleyan University PUBLIC  PRIVATE
- 5. USE: Present: Vacant/storage Historic: Physics Building
- 6. ACCESSIBILITY TO PUBLIC: Exterior visible from public road:  yes  no  
Interior accessible:  yes, explain with permission  no

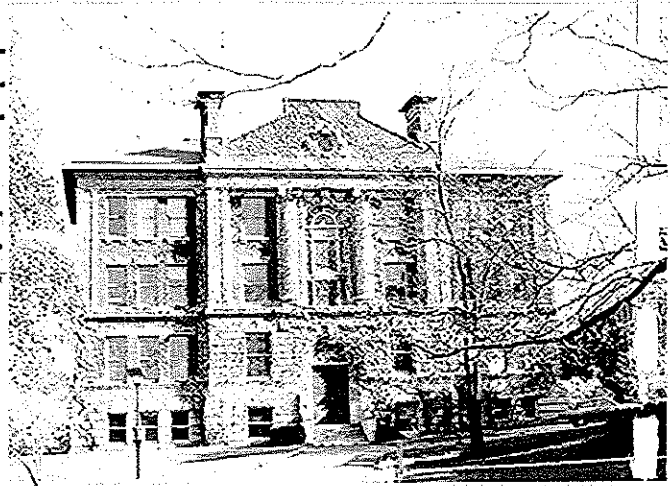
photographer: Roger Sherman  
date: 6/78 view: north  
negative on file: Roll 21, #30

Main facade: leaded stained glass window; ornate stone detail  
Interior: large wooden central staircase

Like other colleges, Wesleyan experienced marked growth in the first decade of the twentieth century. This building and Fisk Hall were both constructed in 1903. Scott was designed by Charles A. Rich, a notable collegiate architect. The most distinctive feature of this Renaissance Revival structure, presently masked by ivy, is its tall central pavillion. Rusticated stone surrounds the round arched main portal. Above the first story, two engaged columns flank a two story round arched window bay. The upper portion of the bay contains a large leaded stained glass window. A cartouche-like oval window is displayed on the stepped pedimented gable. These elements are ornately decorated by swags and other intricate details. Smooth and sculpted limestone details set against the brick walls produce a variety of form and color.

none known  highways  vandalism  developers  other: \_\_\_\_\_  
 renewal  private  deterioration  zoning  explanation: Ivy has overgrown

the surface of the building to such an extent that its distinctive features are hidden and prone to deterioration.
