HISTORIC RESOURCES INVENTORY FORM
For Buildings and Structures

- 1. BUILDING NAME: Common: _____ Historic: Danforth Pewter Shop
- 2. TOWN/CITY: Middletown VILLAGE: _____ COUNTY: Middlesex
- 3. STREET & NUMBER (and/or location): 120 College Street
- 4. OWNER(S): Farmer's & Mechanic's Savings Bank PUBLIC PRIVATE
- 5. USE: Present: Vacant Historic: Pewter Shop; apartments
- 6. ACCESSIBILITY TO PUBLIC: Exterior visible from public road: yes no
Interior accessible: yes, explain with owner's permission no

Danforth Pewter Shop
120 College Street, Middletown, Ct. 06457

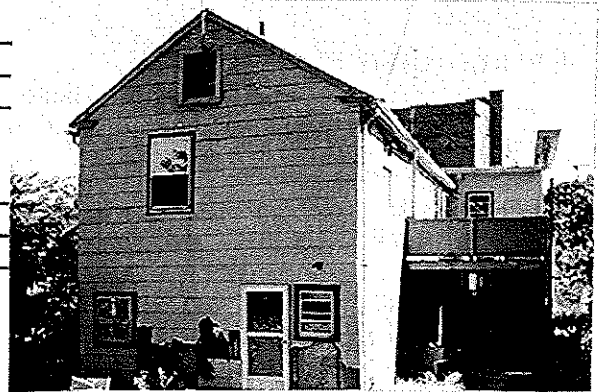
photographer: Robert Svec
date: 9/78 view: north
negative on file: Roll 31, #31

- 7. STYLE OF BUILDING: Italianate front applied to Colonial Shop DATE OF CONSTRUCTION: c. 1759
- 8. MATERIAL(S) (indicate use or location when appropriate):
 clapboard under siding asbestos siding ___ brick
___ wood shingle ___ asphalt siding ___ fieldstone
___ board & batten ___ stucco ___ cobblestone
___ aluminum siding ___ concrete: type: _____ cut stone: type: brownstone
___ other: _____ foundation

- 11. NUMBER OF STORIES: 2 APPROXIMATE DIMENSIONS: Italianate addition 30'x20'
- 12. CONDITION: Structural: ___ excellent good ___ fair ___ deteriorated
Exterior: ___ excellent ___ good fair ___ deteriorated

16. INTERRELATIONSHIP OF BUILDING AND SURROUNDINGS: This building faces south from the north side of College Street between Main and Broad Streets. To the east is the parking lot of the Farmer's & Mechanic's Bank, and to the west is a colonial house to which this structure was once attached as a dependency. Across College Street is a vacant theater and lot

awaiting redevelopment. The original portion of this structure was set back from the street; a subsequent addition to the front is in line with the neighboring structures close to the street.
