HISTORIC RESOURCES INVENTORY FORM

- 1. BUILDING NAME: Common: _____ Historic: Joseph Danforth House
- 2. TOWN/CITY: Middletown VILLAGE: _____ COUNTY: Middlesex
- 3. STREET & NUMBER (and/or location): 122-124 College Street
- 4. OWNER(S): Farmer's & Mechanic's Savings Bank PUBLIC PRIVATE
- 5. USE: Present: Vacant Historic: Residence
- 6. ACCESSIBILITY TO PUBLIC: Exterior visible from public road: yes no
Interior accessible: yes, explain with owner's permission no

Joseph Danforth House
122-124 College Street, Middletown, Ct. 06457

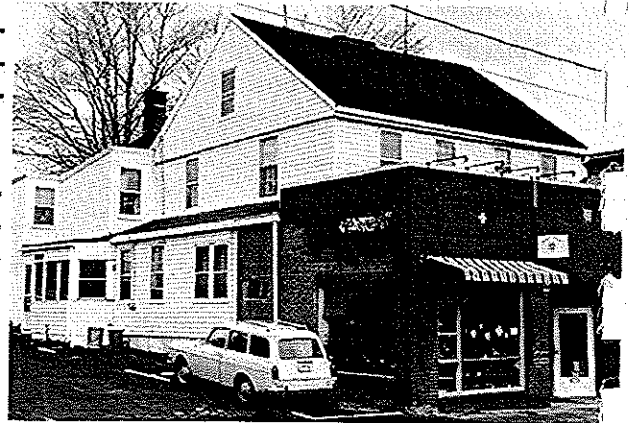
photographer: Robert Svec
date: 11/77 view: southwest
negative on file: Roll 5, #32A

The Joseph Danforth House was originally of a four-bay, center-chimney configuration with the entrance in the third bay to the east. This type of construction was not uncommon in eighteenth century Middletown; however, few examples remain. Many subsequent additions and alterations have buried the original appearance of this structure. These include a brick storefront, a 2 1/2 story rear wing, and the division of the interior into seven apartments. site investigation has revealed the original fireplaces and other structural evidence which

demonstrate the plan of the house as it was built.
