HISTORIC RESOURCES INVENTORY FORM
for Buildings and Structures

- 1. BUILDING NAME: Common: _____ Historic: Jedediah Wilcox House
- 2. TOWN/CITY: Middletown VILLAGE: Westfield COUNTY: Middlesex
- 3. STREET & NUMBER (and/or location): 1456 Country Club Road
- 4. OWNER(S): Carl A. Anderson et al. PUBLIC PRIVATE
- 5. USE: Present: Residence Historic: same
- 6. ACCESSIBILITY TO PUBLIC: Exterior visible from public road: yes no
Interior accessible: yes, explain with owner's permission no

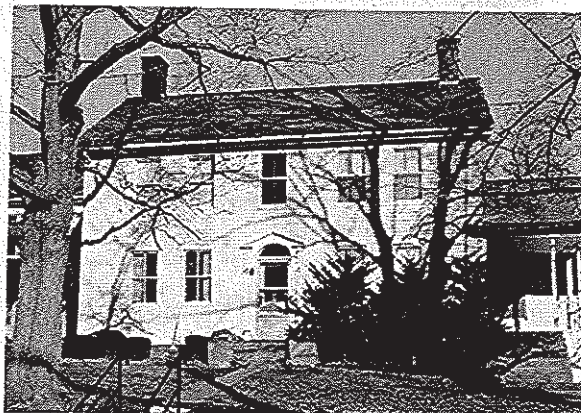
PHOTOGRAPH

Fanlight in each gable peak
Elaborately detailed doorway with leaded fanlight in broken pediment

The entrance of this center-hall house is certainly the most elaborately decorated example of a Federal doorway in Middletown. Finely carved pilasters support a broken pediment over a fanlight divided by elaborate leadwork.

photographer: John Reynolds
date: 11/78 view: north
negative on file: Roll 51, #24-24A
