HISTORIC RESOURCES INVENTORY FORM
for Buildings and Structures

- 1. BUILDING NAME: Common: Falcons Building Historic: Masonic Hall
- 2. TOWN/CITY: Middletown VILLAGE: _____ COUNTY: Middlesex
- 3. STREET & NUMBER (and/or location): 181-183 Court Street
- 4. OWNER(S): Polish Falcons Inc. PUBLIC PRIVATE
- 5. USE: Present: Club Headquarters; retail 1st floor Historic: Masonic Headquarters
- 6. ACCESSIBILITY TO PUBLIC: Exterior visible from public road: xyes no
Interior accessible: xyes, explain with permission no

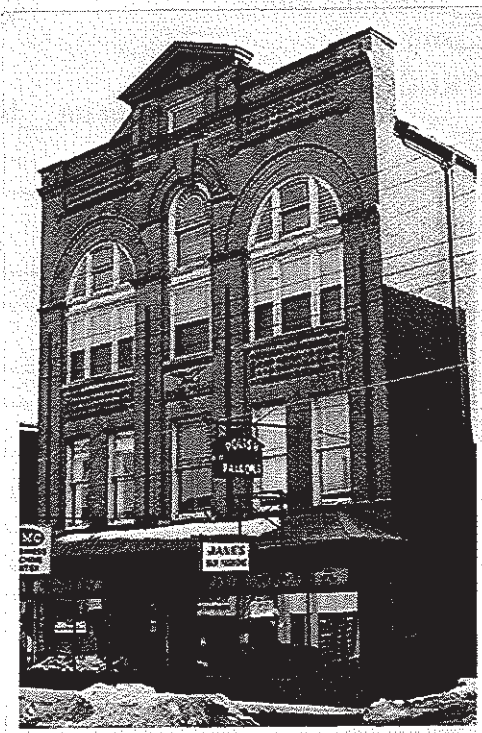
photographer: Elizabeth Loomis
date: 1/78 view: north
negative on file: Roll 11, #27

This building's symmetrical three-bay facade displays elements of the Renaissance Revival style. The second and third story windows are enclosed in an arcade; a large brownstone keystone protrudes from the middle arch. Other notable features include a small elevated pediment with a rising sun design, groups of coursed terra cotta tile and brownstone trim.
