HISTORIC RESOURCES INVENTORY FORM
for Buildings and Structures

- 1. BUILDING NAME: Common: Oliver D. Beebe House Historic: same
- 2. TOWN/CITY: Middletown VILLAGE: _____ COUNTY: Middlesex
- 3. STREET & NUMBER (and/or location): 279 Court Street
- 4. OWNER(S): Wesleyan University PUBLIC PRIVATE
- 5. USE: Present: Department of English offices Historic: Residence
- 6. ACCESSIBILITY TO PUBLIC: Exterior visible from public road: yes no
Interior accessible: yes, explain with permission no

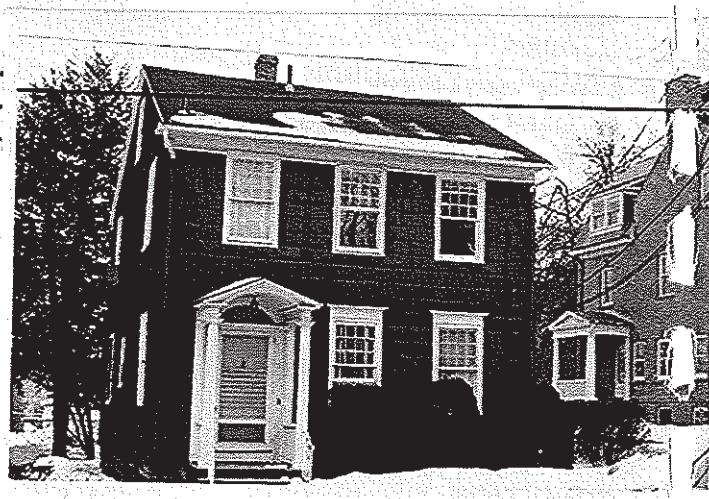
PHOTOGRAPH

Federal entrance porch with cove ceiling

This house displays Federal details such as a fanlight over the entrance and delicate window cornices. It is an example of the three-bay side hall configuration which was a popular type of house construction in the Middletown area. In its early application the gables were placed perpendicular to the street. The Oliver Beebe house is an important surviving example in wood of this early form.

photographer: Elizabeth Loomis
date: 1/78 view: south
negative on file: Roll II, #36A
