HISTORIC RESOURCES INVENTORY FORM
For Buildings and Structures

1. BUILDING NAME: Common: _____ Historic: "Ashcroft" Capt. Giles Wilcox House
2. TOWN/CITY: Middletown VILLAGE: Westfield COUNTY: Middlesex
3. STREET & NUMBER (and/or location): 455 East Street
4. OWNER(S): Helen M. Brainard PUBLIC PRIVATE
5. USE: Present: Residence Historic: same
6. ACCESSIBILITY TO PUBLIC: Exterior visible from public road: yes no
Interior accessible: yes, explain with owner's permission no

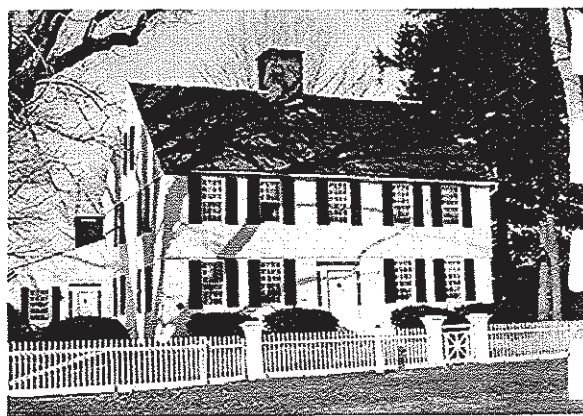
photographer: John E. Reynolds
date: 11/78 view: east
negative on file: Roll 51, #5-5A

16. INTERRELATIONSHIP OF BUILDING AND SURROUNDINGS: This large center-chimney Georgian house faces east on East Street at the head of Poplar Lane. It is set back behind an elaborate white picket fence along the road, and a large ash tree whose high branches frame the house in a picturesque manner. This section of East Street displays several fine old houses in a rural setting with some new development taking place south of Poplar Lane.

This house displays the center-chimney, two room-deep plan typical of 18th century Connecticut Valley house construction. A denticulated main cornice distinguishes the facade, while the interior displays much original paneling, wainscoting, hardware, etc. The southwest wing was originally a small center-chimney house which pre-dated this one. It was moved and attached for use as a kitchen wing over 100 years ago.
