HISTORIC RESOURCES INVENTORY FORM

for Buildings and Structures

- 1. BUILDING NAME: Common: _____ Historic: Elisha Sears House
- 2. TOWN/CITY: Middletown VILLAGE: _____ COUNTY: Middlesex
- 3. STREET & NUMBER (and/or location): 112 East Main Street
- 4. OWNER(S): Russell M. and Mary E. Perking PUBLIC PRIVATE
- 5. USE: Present: Residence Historic: same
- 6. ACCESSIBILITY TO PUBLIC: Exterior visible from public road: yes no
Interior accessible: yes, explain _____ no

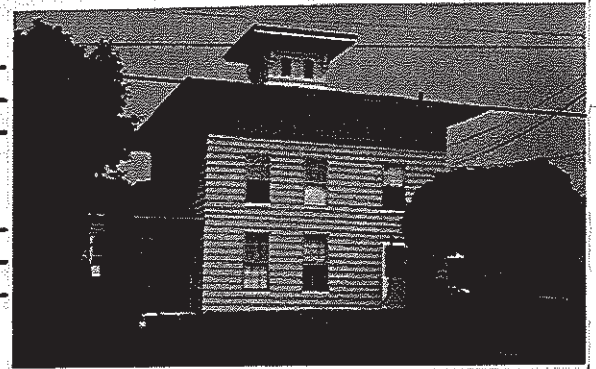
PHOTOGRAPH

18. HISTORICAL OR ARCHITECTURAL IMPORTANCE: This residence, first owned by Elisha Sears, may have been erected soon after the property was mortgaged in 1854. Sears taught school for many years in the Hubbard and South Farms Districts. The house, exhibiting a large rectangular profile, is of the Italianate style. It features a wide cornice with dentils displayed on the frieze beneath and a distinctive narrow cupola. Like the roof of the building, the cupola has an unusually wide cornice. It is further decorated by thin scrolled brackets and small ogee-like, arched windows.

date: 6/78 view: west
