HISTORIC RESOURCES INVENTORY FORM
for Buildings and Structures

- 1. BUILDING NAME: Common: _____ Historic: Isaac Warner House
- 2. TOWN/CITY: Middletown VILLAGE: _____ COUNTY: Middlesex
- 3. STREET & NUMBER (and/or location): 33 Ferry Street
- 4. OWNER(S): Salvatore Damiata PUBLIC PRIVATE
- 5. USE: Present: Residential (apartments) Historic: Residential
- 6. ACCESSIBILITY TO PUBLIC: Exterior visible from public road: yes no
Interior accessible: yes, explain with owner's permission no

- 7. STYLE OF BUILDING: Federal DATE OF CONSTRUCTION: ca. 1817
- 8. MATERIAL(S) (indicate use or location when appropriate):

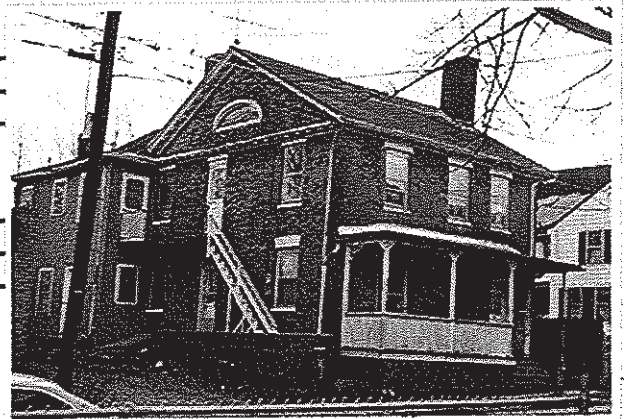
photographer: Wayne Svec
date: 1/78 view: north-east
negative on file: Roll 7 #4A

- 13. INTEGRITY: Location: on original site moved, when: _____
Alterations: no yes, explain: Entrance porch widened; front entrance moved; wings added in rear; front facade openings changed.
