HISTORIC RESOURCES INVENTORY FORM
For Buildings and Structures

- 1. BUILDING NAME: Common: Wesleyan Physical Plant Historic: _____
- 2. TOWN/CITY: Middletown VILLAGE: _____ COUNTY: Middlesex
- 3. STREET & NUMBER (and/or location): 58 Hamlin Street
- 4. OWNER(S): Wesleyan University PUBLIC PRIVATE
- 5. USE: Present: Office & Maintenance Quarters Historic: Industrial
- 6. ACCESSIBILITY TO PUBLIC: Exterior visible from public road: yes no
Interior accessible: yes, explain permission of security officer no

Wesleyan Physical Plant
58 Hamlin Street, Middletown, CT 06457

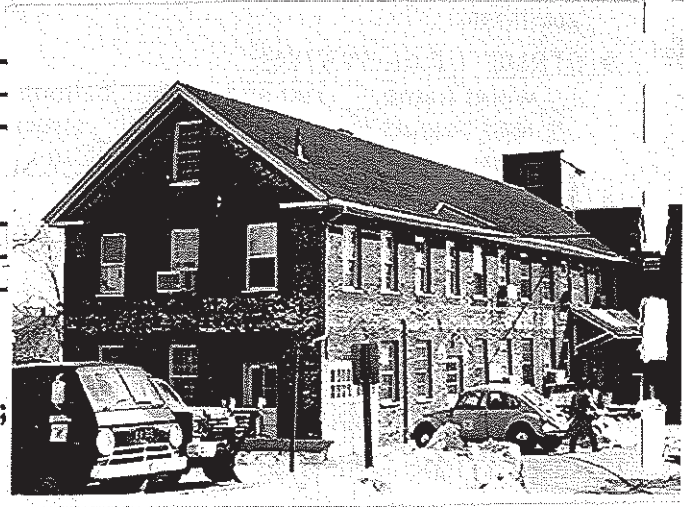
photographer: Elizabeth Loomis
date: 2/78 view: northwest
negative on file: Roll 13, #33A

Early scales set into first floor (visible from basement)
Early elevator in addition; built by Eastern Machinery Co., New Haven, Conn.
Trap door in attic
Wooden lintel (probably for a loading beam) on second story east side

The main original section displays the typical domestic scale of early nineteenth century industrial buildings. The brick work and fenestration are reminiscent of the Federal-Greek style, but there are few decorative details.
