STATE OF CONNECTICUT
 CONNECTICUT HISTORICAL COMMISSION
 59 South Prospect Street, Hartford, Connecticut 06106
 (203) 566-3005
 HISTORIC RESOURCES INVENTORY FORM
 For Buildings and Structures

1. BUILDING NAME: Common: Giacco House Historic: E.B. Strong House
 TOWN/CITY: Middletown VILLAGE: _____ COUNTY: Middlesex
 3. STREET & NUMBER (and/or location): 465 High Street
 OWNER(S): A. Giacco PUBLIC PRIVATE
 5. USE: Present: Residence Historic: same
 ACCESSIBILITY TO PUBLIC: Exterior visible from public road: yes no
 Interior accessible: yes, explain _____ no

7. STYLE OF BUILDING: Late 19th Century Domestic; Queen Anne DATE OF CONSTRUCTION: 1871-1872

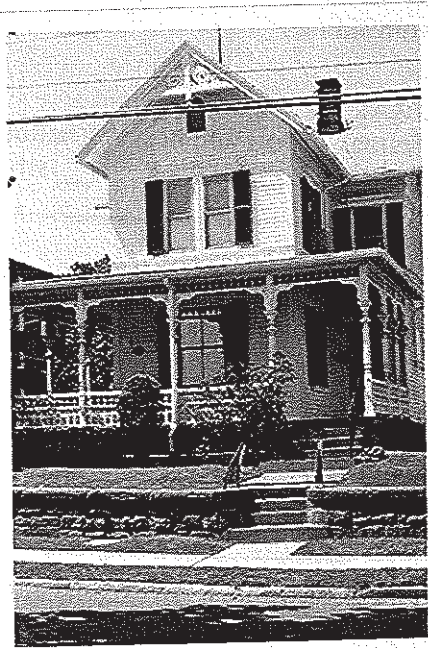
PHOTOGRAPH

The Strong House is an outstanding example of applied wooden decorative detail. Each of the four gable ends is ornamented with scroll-saw work, crossed sticks, and a pendant. All of the window and door lintels are embellished with a sawn floral pattern or a decorative molding. A belt course of shaped shingles and carved wooden emblems separates the first and second stories. The porch design is complex, including elaborately turned posts and balusters. The rich detail also extends to the carriage house with its bracketed grape arbor.

photographer: Roger Sherman
date: 7/78 view: east
negative on file: Roll 25A, #3
