HISTORIC RESOURCES INVENTORY FORM
For Buildings and Structures

- 1. BUILDING NAME: Common: _____ Historic: Russell Company Houses
- 2. TOWN/CITY: Middletown VILLAGE: South Farms COUNTY: Middlesex
- 3. STREET & NUMBER (and/or location): 1,2,3,4,5,6,7 & 8 Hillside Court
- 4. OWNER(S): See next page (below #21) PUBLIC PRIVATE
- 5. USE: Present: Residences Historic: Company Housing
- 6. ACCESSIBILITY TO PUBLIC: Exterior visible from public road: yes no
Interior accessible: yes, explain _____ no

Russell Company Houses
Hillside Court, Middletown, Ct. 06457

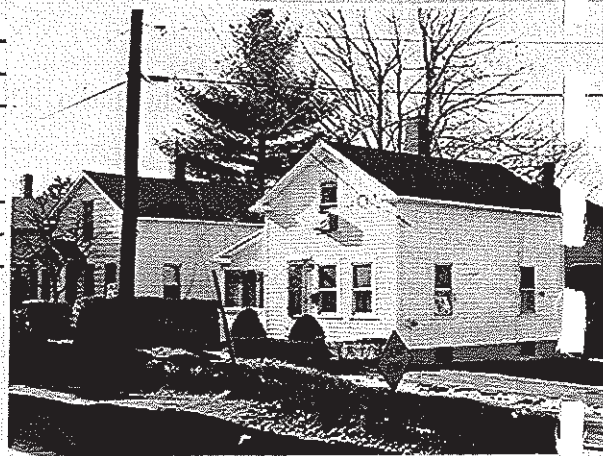
A: 1 and 3 Hillside Court

18. HISTORICAL OR ARCHITECTURAL IMPORTANCE: This group of cottages was built by the Russell Manufacturing Company as housing for its workers. In 1927, the company sold these houses to the occupants. They are practically identical in appearance despite minor alterations; each building has the same original L-shaped floor plan. The rectangular main section displays a plain three-bay facade with the doorway set to the side and one second-story window. Each house has an enclosed side porch with a shed roof.

photographer: Robert Svec
date: 10/78 view: A, east; B, looking south
negative on file: A, Roll 53, #12A-B; B, Roll 40, #10
