HISTORIC RESOURCES INVENTORY FORM
For Buildings and Structures

- BUILDING NAME: Common: _____ Historic: Nehemiah Hubbard House
- TOWN/CITY: Middletown VILLAGE: _____ COUNTY: Middlesex
- STREET & NUMBER (and/or location): Laurel Grove Road; west side, just south of Wadsworth St.
- OWNER(S): Peter Flagg PUBLIC PRIVATE
- USE: Present: Residence Historic: same
- ACCESSIBILITY TO PUBLIC: Exterior visible from public road: yes no
Interior accessible: yes, explain with owner's permission no

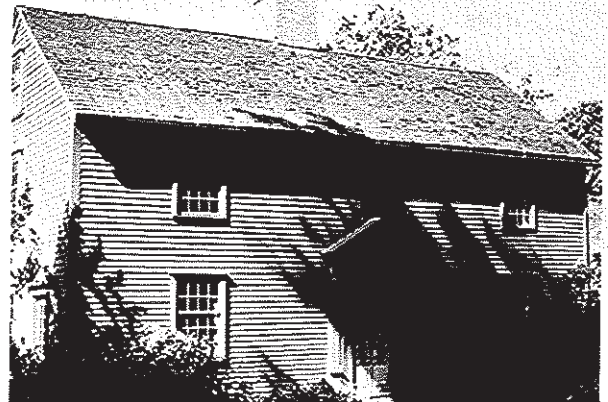
PHOTOGRAPH

- INTERRELATIONSHIP OF BUILDING AND SURROUNDINGS: This Colonial "saltbox" house is sited on a large lot at the rural western edge of Middletown. Screened from the front by bushes, trees, and a stone wall, and on the east by a cedar paling fence, the house is very secluded. A two-story gambrel-roofed wing on the west, a two-car garage on the north, and a large nineteenth century barn south of the house complete the estate.

This 1744 center-chimney saltbox retains most of its early features, both interior and exterior. The main fireplace with its beehive oven measures over eight feet wide. Much early hardware remains. The two-story gambrel-roofed "kitchen wing" is added, but is sympathetic in style with the original house. The house underwent restoration in 1929 by the Colonel Wadsworth family. It continues to be used as a residence by members of the Peter Flag family.

photographer: Roger Sherman
date: 9/78 view: east
negative on file: Roll 43, #33-33A
