HISTORIC RESOURCES INVENTORY FORM

- 1. BUILDING NAME: Common: Middlesex Fruiterery Historic: Police Station
- 2. TOWN/CITY: Middletown VILLAGE: _____ COUNTY: Middlesex
- 3. STREET & NUMBER (and/or location): 191-195 Main Street
- 4. OWNER(S): City of Middletown PUBLIC PRIVATE
- 5. USE: Present: Commercial Historic: Commercial; Police Station
- 6. ACCESSIBILITY TO PUBLIC: Exterior visible from public road: yes no
Interior accessible: yes, explain publicly owned, commercial use no

Police Station
191-195 Main Street, Middletown, CT 06457

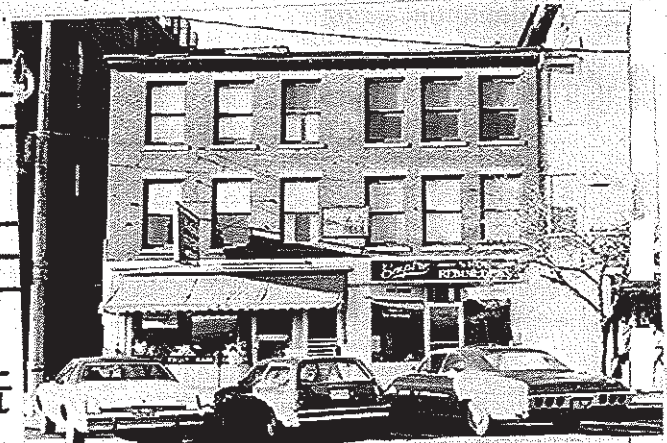
photographer: John E. Reynolds
date: 10/78 view: east
negative on file: Roll 50, #35

- 7. STYLE OF BUILDING: Plain 19th century commercial DATE OF CONSTRUCTION: ca. 1835
- 8. MATERIAL(S) (indicate use or location when appropriate):
 clapboard asbestos siding brick
 wood shingle asphalt siding fieldstone
 board & batten stucco cobblestone
 aluminum siding concrete: type: _____ cut stone: type: brownstone
 other: _____ sills & lintels

- 11. NUMBER OF STORIES: 3 APPROXIMATE DIMENSIONS: 36'x70'
- 12. CONDITION: Structural: excellent good fair deteriorated
 Exterior: excellent good fair deteriorated

- 13. INTEGRITY: Location: on original site moved, when: _____
 Alterations: no yes, explain: Rear wing, full third story; front facade added ca. 1891
- 14. RELATED OUTBUILDINGS OR LANDSCAPE FEATURES:
 barn shed garage other landscape features or buildings: passway on
 carriage house shop garden south side and in rear
