UNIVERSAL RESOURCES INVENTORY FORM
 for Buildings and Structures

1. BUILDING NAME: Common: Bacon Brothers Historic: Hubbard-Holland Building
 2. TOWN/CITY: Middletown VILLAGE: _____ COUNTY: Middlesex
 3. STREET & NUMBER (and/or location): 359 Main Street
 4. OWNER(S): Bacon Brothers, Incorporated PUBLIC PRIVATE
 5. USE: Present: Commercial Historic: Commercial and residential
 6. ACCESSIBILITY TO PUBLIC: Exterior visible from public road: yes no
 Interior accessible: yes, explain first floor store; upper stories with permission no

Hubbard-Holland Building
359 Main St., Middletown, Ct. 06457

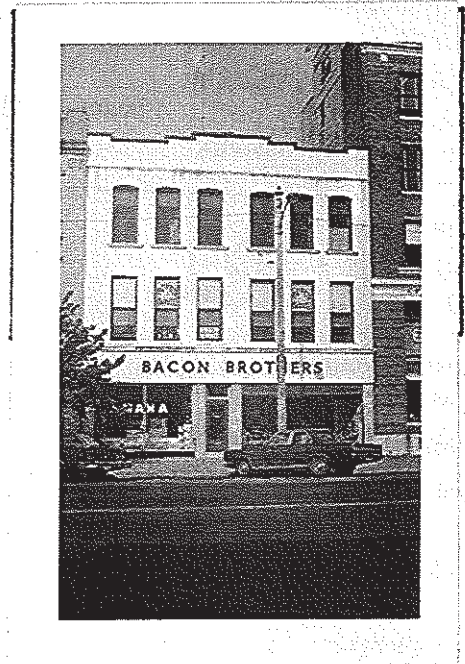
photographer: Elizabeth Loomis
date: 5/78 view: east
negative on file: Roll 25, #27

14. INTERRELATIONSHIP OF BUILDING AND SURROUNDINGS: This three story structure sits on the west side of Main Street in Middletown's central business district. Affixed to its north wall is the later, five story, Hartford National Bank. Directly to the south is a plain four story commercial building.

The configuration of this structure has changed considerably since its erection. It originally consisted of two sections: a three story, three-bay store with living quarters to the north; and a one story store to the south. Sometime in the early 1900's the one story section was raised, and a new stuccoed facade integrated the two sections. Although the first floor has been modernized, the upper stories retain many of their original features;
