HISTORIC RESOURCES INVENTORY FORM  
For Buildings and Structures

- 1. BUILDING NAME: Common: Richard E. Cody Shoes Historic: Ward-Cody Building
- 2. TOWN/CITY: Middletown VILLAGE: \_\_\_\_\_ COUNTY: Middlesex
- 3. STREET & NUMBER (and/or location): 502-508 Main Street
- 4. OWNER(S): Edward D. and Catherine E. Cody PUBLIC  PRIVATE
- 5. USE: Present: Commercial Historic: same
- 6. ACCESSIBILITY TO PUBLIC: Exterior visible from public road:  yes  no  
Interior accessible:  yes, explain \_\_\_\_\_ commercial use \_\_\_\_\_ no

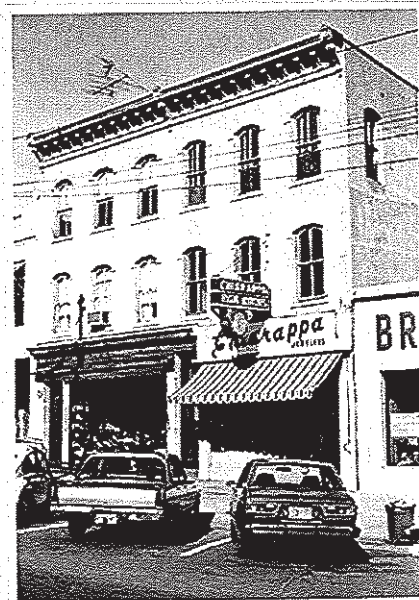
PHOTOGRAPH

The Ward-Cody building is a good example of a late-19th century, brick, commercial building. It is three stories in height and contains six windows on each floor. Decorative elements are scarce, with only the cornice and arched windows exhibiting detailing. The early north store front of "Richard E. Cody Shoes," probably dating from the early 20th century, is still intact. Two curved bays rest on bases sheathed with copper. The signboard and cornice of the storefront are also of copper, and display the legend "Richard E. Cody Shoes." That storefront is an important survival of an early 20th century treatment of a commercial facade.

photographer: Elizabeth Loomis  
date: 10/78 view: east  
negative on file: Roll 46, #2-2A
