HISTORIC RESOURCES INVENTORY FORM
For Buildings and Structures

- 1. BUILDING NAME: Common: Graves Homestead Historic: Rev. Joseph Graves House
- 2. TOWN/CITY: Middletown VILLAGE: Westfield COUNTY: Middlesex
- 3. STREET & NUMBER (and/or location): Miner Street; south side, .2 miles west of East Street
- 4. OWNER(S): First Federal Savings & Loan Association of Meriden PUBLIC PRIVATE
- 5. USE: Present: Possibly vacant Historic: Residence
- 6. ACCESSIBILITY TO PUBLIC: Exterior visible from public road: yes no
Interior accessible: yes, explain _____ no

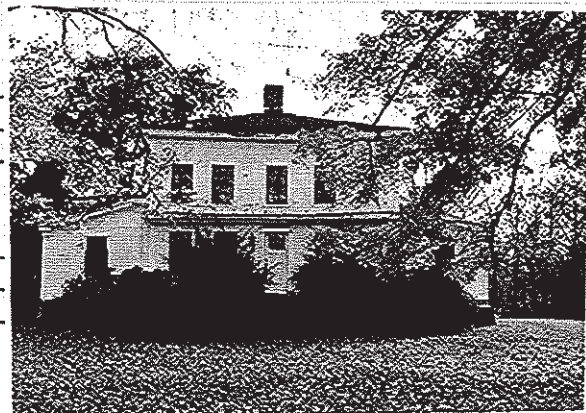
PHOTOGRAPH

This finely scaled center-chimney house features a low hip roof set off by a denticulated cornice. The symmetry of the five-bay facade is preserved through the addition of identical wings at each end. Although presently unoccupied and in deteriorating condition, this house is important to Miner Street due to its unique architecture and long association with the Graves family.

photographer: Elizabeth Loomis
date: 10/78 view: north
negative on file: Roll 30A-31
