CONNECTICUT HISTORICAL COMMISSION59 South Prospect Street, Hartford, Connecticut 06106
(203) 566-3005**HISTORIC RESOURCES INVENTORY FORM**

1. BUILDING NAME: Common: _____ Historic: James G. Hubbard House
2. TOWN/CITY: Middletown VILLAGE: _____ COUNTY: Middlesex
3. STREET & NUMBER (and/or location): 78 Pearl Street
4. OWNER(S): Mildred Meader PUBLIC PRIVATE
5. USE: Present: Residence Historic: same
6. ACCESSIBILITY TO PUBLIC: Exterior visible from public road: yes no
Interior accessible: yes, explain _____ no

James G. Hubbard House
78 Pearl Street, Middletown, CT 06457

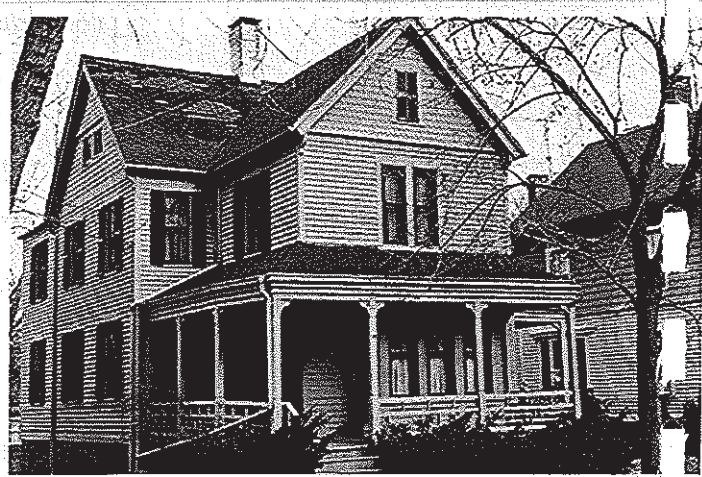
photographer: Elizabeth Loomis
date: 11/77 view: west
negative on file: Roll 1, #20

This is a fine and well preserved example of a popular late 19th century cross-gable-plan house type. The house retains virtually all of its original exterior features including clapboards, shingled gable ends and three-sided veranda.
