HISTORIC RESOURCES INVENTORY FORM
For Buildings and Structures

- 1. BUILDING NAME: Common: South Congregational Church Historic: same
- 2. TOWN/CITY: Middletown VILLAGE: _____ COUNTY: Middlesex
- 3. STREET & NUMBER (and/or location): 9 Pleasant Street
- 4. OWNER(S): South Congregational Church PUBLIC PRIVATE
- 5. USE: Present: Church Historic: same
- 6. ACCESSIBILITY TO PUBLIC: Exterior visible from public road: yes no
Interior accessible: yes, explain house of worship no

South Congregational Church
9 Pleasant Street, Middletown, Ct. 06457

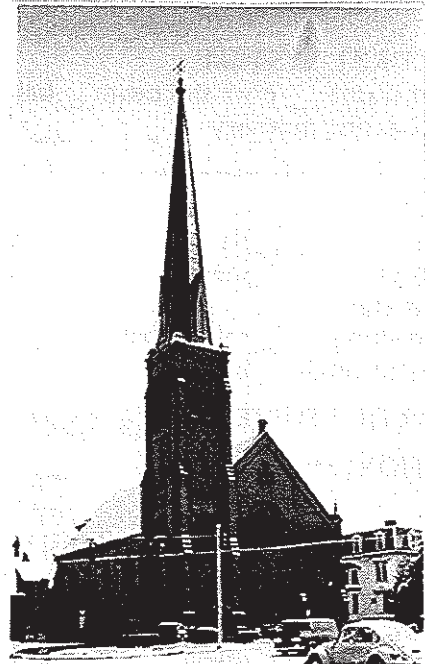
PHOTOGRAPH

The South Congregational Church is one of a number of Gothic Revival, brick and brownstone churches built in Middletown after the Civil War. Like most of the others, this church displays a steeply pitched slate roof, and a tower with a tall spire. The buttressed walls

photographer: Barbara Ann Cleary
date: 8/78 view: northeast
negative on file: Roll 9, #10A-11

have lancet windows. The facade, with its elaborate circular stained glass windows depicting religious motifs, is visible for almost the length of Main Street.

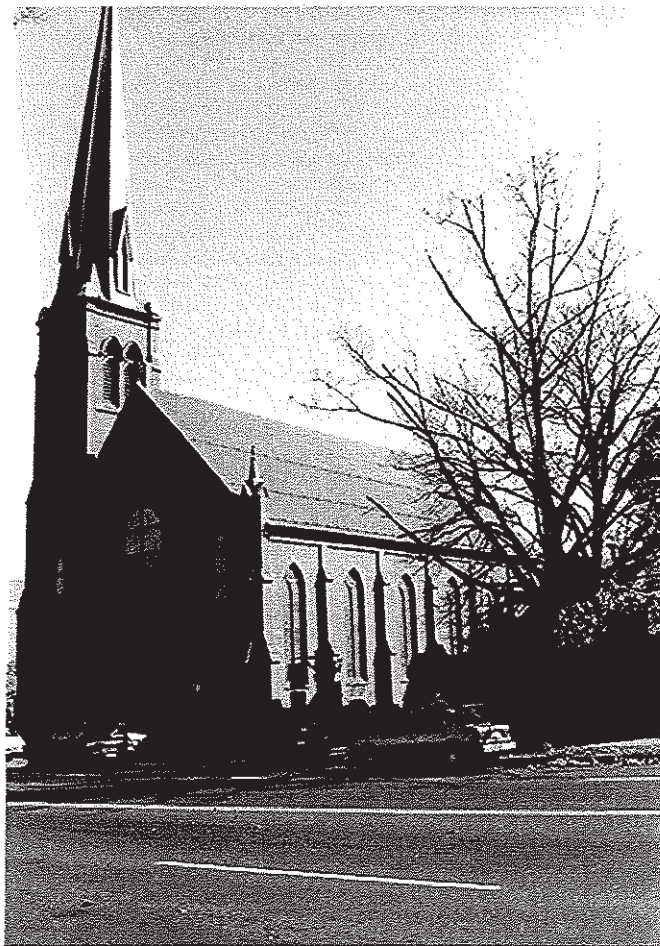
South Congregational Church
9 Pleasant Street, Middletown, CT 06457
