HISTORIC RESOURCES INVENTORY FORM

For Buildings and Structures

- 1. BUILDING NAME: Common: _____ Historic: Crowell Family House
- 2. TOWN/CITY: Middletown VILLAGE: _____ COUNTY: Middlesex
- 3. STREET & NUMBER (and/or location): Randolph Rd., south side; between Maple Shade & Arbutus St.
- 4. OWNER(S): Cornelius & Katherine Kruse PUBLIC PRIVATE
- 5. USE: Present: Residence Historic: same
- 6. ACCESSIBILITY TO PUBLIC: Exterior visible from public road: yes no
Interior accessible: yes, explain _____ no

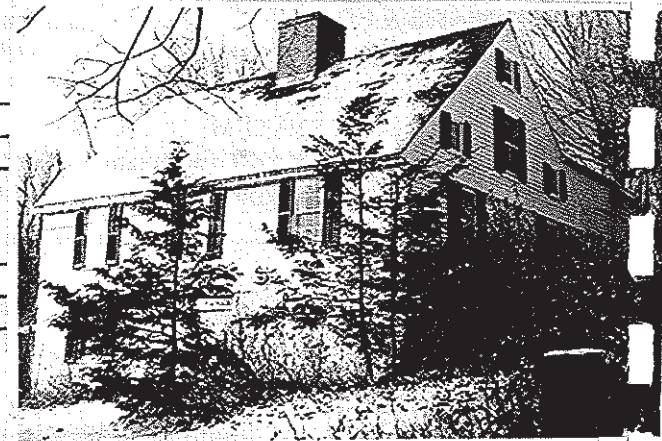
photographer: Elizabeth Loomis
date: 12/78 view: northeast
negative on file: Roll 54, #24A-25

16. INTERRELATIONSHIP OF BUILDING AND SURROUNDINGS: This house is sited into a hill on the east side of Randolph Road, with its gable end facing the street. Although close to the road, it is shaded from it by trees and bushes. Some post-World War II housing in the near vicinity has begun to alter the traditional rural character of the Long Hill district.

The house is a small, 1½-story, center-chimney Colonial structure. It is unusually sited, with the gable end close to the street. Built into a hill, the full basement of brownstone is exposed on the main (east) facade. The house is in good condition, with original narrow clapboarding and window sash, and is an important survival from the early days of the settlement of the Long Hill area of Middletown.
