HISTORIC RESOURCES INVENTORY FORM  
For Buildings and Structures

- 1. BUILDING NAME: Common: Sebold's Apartments Historic: M.A. Smith Grocery
- 2. TOWN/CITY: Middletown VILLAGE: \_\_\_\_\_ COUNTY: Middlesex
- 3. STREET & NUMBER (and/or location): 26-28 Saybrook Road
- 4. OWNER(S): James and Rosalie Bennett PUBLIC  PRIVATE
- 5. USE: Present: Vacant Historic: General store, residential
- 6. ACCESSIBILITY TO PUBLIC: Exterior visible from public road:  yes  no  
Interior accessible:  yes, explain \_\_\_\_\_  no

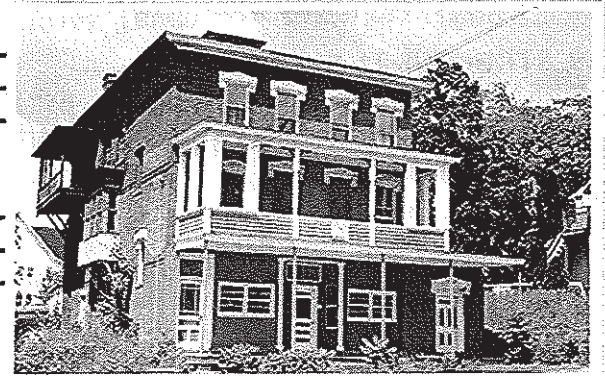
photographer: Elizabeth Loomis  
date: 6/78 view: northwest  
negative on file: Roll 26, #2

Cupola  
Decorative pressed metal lintels  
"Saw tooth" belt courses  
M.A. Smith Grocery sign, painted on north wall

Subsequently the building was altered for apartment use. It is now unoccupied. In this utilitarian building nineteenth-century quality of workmanship is reflected in the wooden and brick decorative detail, pressed metal sheathing on the lintels, the cupola and the veranda.
