HISTORIC RESOURCES INVENTORY FORM
of Buildings and Structures

- 1. BUILDING NAME: Common: _____ Historic: Samuel B. Harris House
- 2. TOWN/CITY: Middletown VILLAGE: South Farms COUNTY: Middlesex
- 3. STREET & NUMBER (and/or location): 60 Saybrook Road
- 4. OWNER(S): Agnes & Eva Carlson PUBLIC PRIVATE
- 5. USE: Present: Residence Historic: same
- 6. ACCESSIBILITY TO PUBLIC: Exterior visible from public road: yes no
Interior accessible: yes, explain _____ no

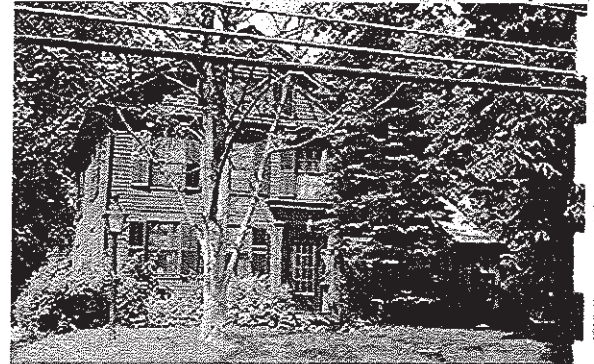
PHOTOGRAPH

- 11. NUMBER OF STORIES: 2½ APPROXIMATE DIMENSIONS: 24'x28' (east extension 22'x25')
- 12. CONDITION: Structural: excellent good fair deteriorated
Exterior: excellent good fair deteriorated

The building has retained its original detail. The three-bay facade, with a pedimented gable to the street, is a later example of a Middletown house type that was extremely popular during the 1830s and early 40s. The pediment is trimmed by a plain frieze and cornice boards. Beneath the gable, a large rectangular window with small, rectangular panes is displayed. The Greek Revival entranceway exhibits a simple entablature supported by pilasters. Rectangular lights frame the door.

photographer: Elizabeth Loomis
date: 6/78 view: west
negative on file: Roll 26, #5A

none known highways vandalism developers other: _____
 renewal private deterioration zoning explanation: Exterior repairs
and maintenance have been neglected.
