HISTORIC RESOURCES INVENTORY FORM
For Buildings and Structures

- 1. BUILDING NAME: Common: _____ Historic: Franklin B. Comstock House
- 2. TOWN/CITY: Middletown VILLAGE: _____ COUNTY: Middlesex
- 3. STREET & NUMBER (and/or location): 57 South Main Street
- 4. OWNER(S): Nathaniel and Tina Gallitto PUBLIC PRIVATE
- 5. USE: Present: Residence Historic: same
- 6. ACCESSIBILITY TO PUBLIC: Exterior visible from public road: yes no
Interior accessible: yes, explain with permission no

Franklin B. Comstock House
57 South Main Street, Middletown, CT 06457

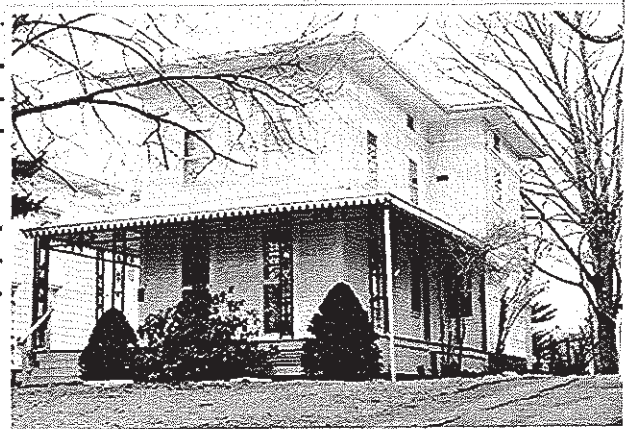
photographer: Elizabeth Loomis
date: 4/78 view: east
negative on file: Roll 18, #4A

Tuscan verandah with delicate ironwork

This house displays a symmetrical appearance; a narrow two-bay central section is flanked by shallow wings of the same height. A verandah of delicate ironwork supporting a canopy roof has a distinct Tuscan feeling and resembles verandahs on the slightly earlier Alsop (301 High Street) and E.W.N. Starr (298 High Street) houses. Also similar is the plain treatment of the unbracketed projecting eaves on this house.
