HISTORIC RESOURCES INVENTORY FORM  
for Buildings and Structures

- 1. BUILDING NAME: Common: \_\_\_\_\_ Historic: Russell Frisbie House
- 2. TOWN/CITY: Middletown VILLAGE: \_\_\_\_\_ COUNTY: Middlesex
- 3. STREET & NUMBER (and/or location): 61 South Main Street
- 4. OWNER(S): Sebastian E. and Anna G. Coronella PUBLIC  PRIVATE
- 5. USE: Present: Residence Historic: same
- 6. ACCESSIBILITY TO PUBLIC: Exterior visible from public road:  yes  no  
Interior accessible:  yes, explain with permission of owner  no

Russell Frisbie House  
61 South Main Street, Middletown, CT 06457

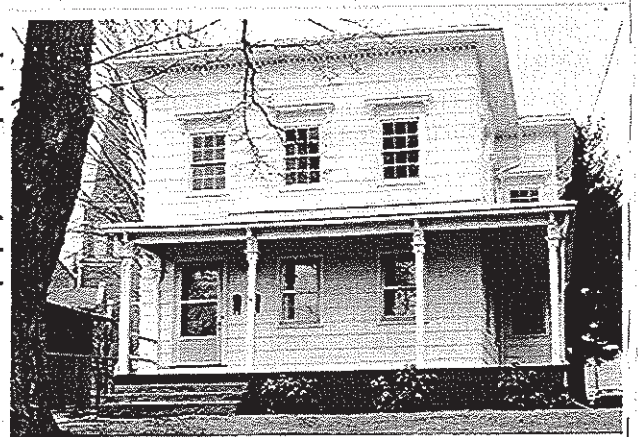
photographer: Elizabeth Loomis  
date: 4/78 view: east  
negative on file: Roll 18, #5A

Window caps  
Denticulated cornice  
Porch columns

This asymmetrical Italianate villa features heavy window heads supported on consoles; a denticulated cornice under the unbracketed eaves; and a verandah across the front and north sides. The porch columns have unusual carved capitals.
