HISTORIC RESOURCES INVENTORY FORM
for Buildings and Structures

- 1. BUILDING NAME: Common: _____ Historic: Abel Wilcox House
- 2. TOWN/CITY: Middletown VILLAGE: _____ COUNTY: Middlesex
- 3. STREET & NUMBER (and/or location): 206 South Main Street
- 4. OWNER(S): Thomas and Ida Burch PUBLIC PRIVATE
- 5. USE: Present: Residence Historic: same
- 6. ACCESSIBILITY TO PUBLIC: Exterior visible from public road: yes no
Interior accessible: yes, explain with permission no

- 7. STYLE OF BUILDING: Colonial DATE OF CONSTRUCTION: c. 1783
- 8. MATERIAL(S) (indicate use or location when appropriate):

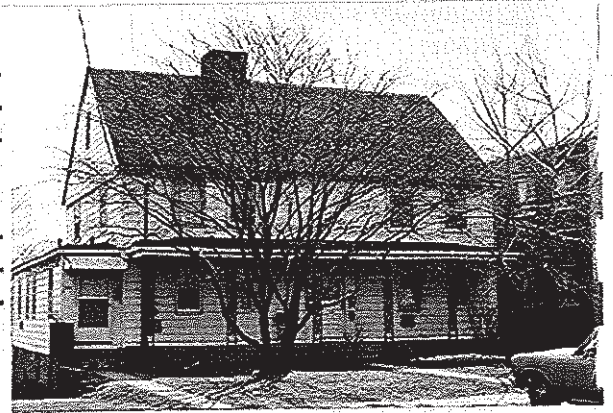
PHOTOGRAPH

Unfortunately, little of the original fabric of this house remains. It is noteworthy for its historical associations with Jacob Eggleston and for its unusual plan. A center stair rises straight up from the hall with the chimney to the north. This stairway appears to be original to the house. Unusual aspects of the plan (for example, no provision for heating the south rooms) suggest that the original configuration of the house differs from its present form.

photographer: Elizabeth Loomis
date: 4/78 view: west
negative on file: Roll 18, #26A
