HISTORIC RESOURCES INVENTORY FORM for Buildings and Structures

- 1. BUILDING NAME: Common: _____ Historic: Austin Baldwin House
- 2. TOWN/CITY: Middletown VILLAGE: _____ COUNTY: Middlesex
- 3. STREET & NUMBER (and/or location): 388 Washington Street
- 4. OWNER(S): Nicholas Saraceno Realty PUBLIC PRIVATE
- 5. USE: Present: Vacant Historic: Residence
- 6. ACCESSIBILITY TO PUBLIC: Exterior visible from public road: yes no
Interior accessible: yes, explain _____ no

Austin Baldwin House
388 Washington St., Middletown, Ct. 06457

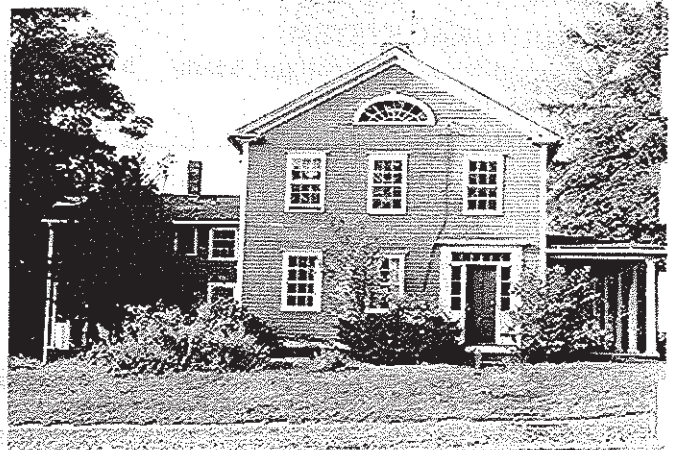
PHOTOGRAPH

- 11. NUMBER OF STORIES: 2½ APPROXIMATE DIMENSIONS: 26'x42' (wing 26'x28')
- 12. CONDITION: Structural: excellent good fair deteriorated
Exterior: excellent good fair deteriorated

- 13. INTEGRITY: Location: on original site moved, when: _____
Alterations: no yes, explain: East porch; early west wing addition; porches added to rear

The Baldwin house is a good example of a type popular in the Middletown area in the 1830s and 1840s. Its three-bay facade with gable facing the street displays Federal and Greek Revival period features. The gable contains an elliptical fanlight and the entranceway is framed by rectangular sidelights with thin, delicate pilasters. The interior retains its original floor plan with a side stair hall, and some original moldings. Late 19th century additions include the west wing and the plain east veranda with its large, stocky columns.

photographer: Elizabeth Loomis
date: 10/78 view: south
negative on file: Roll 48, S #6A-7
