HISTORIC RESOURCES INVENTORY FORM

- 1. BUILDING NAME: Common: Masonic Temple Historic: White-Stoddard House
- 2. TOWN/CITY: Middletown VILLAGE: _____ COUNTY: Middlesex
- 3. STREET & NUMBER (and/or location): 33 Pleasant Street
- 4. OWNER(S): Masonic Building Association PUBLIC PRIVATE
- 5. USE: Present: Offices Historic: Residence
- 6. ACCESSIBILITY TO PUBLIC: Exterior visible from public road: yes no
Interior accessible: yes, explain with permission no

White-Stoddard House
33 Pleasant Street, Middletown, Ct. 06457

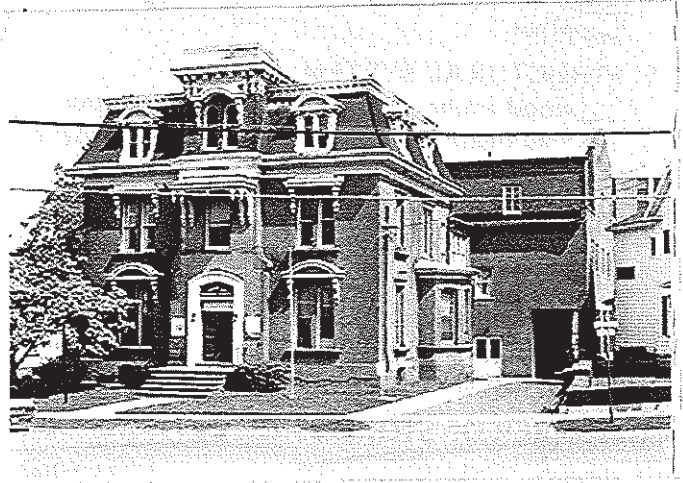
PHOTOGRAPH

This building displays the form of the Second Empire style on a large scale. The ornamentation is similarly large and elaborate. The projecting pavillion is accented by double doors, arched windows on the second story, and a hood supported by elaborate paired brackets. It is capped by the base of a cupola (now removed). The windows have brownstone sills and lintels and are capped with decorative arches. A three-story bay affixed to the south wall

photographer: Roger Sherman
date: 6/78 view: north
negative on file: Roll 21, #14

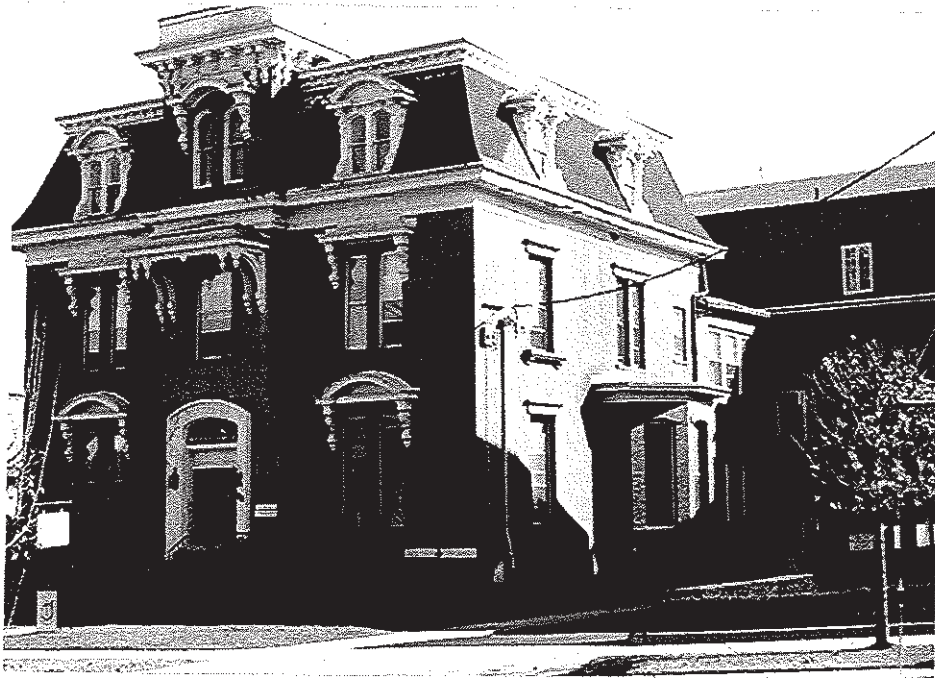
White-Stoddard House

33 Pleasant Street, Middletown, CT 06457
