HISTORIC RESOURCES INVENTORY FORM
For Buildings and Structures

1. BUILDING NAME: Common: Santangelo House Historic: Mather-Douglas Mansion

3. STREET & NUMBER (and/or location): 11 South Main Street

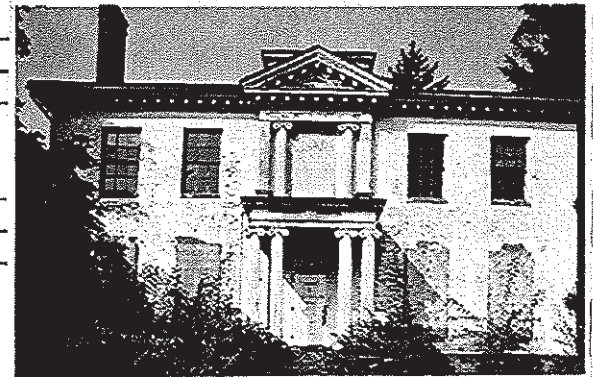
photographer: Elizabeth Loomis
date: 9/78 view: east
negative on file: Roll 39, #28

Douglas was probably responsible for the elaborate alterations. These include the two-story entranceway pavillion with severe Ionic columns, cupola, modillioned cornice, and balustrade. Douglas may have been the one to paint the brick walls and decorative trim contrasting colors. Heavy Italianate moldings and door frames and marble fireplaces were installed in the interior. This remodeling effectively transformed the building stylistically, giving it a substantial and ornate appearance.

The Fraternal Order of the Eagles acquired the property in 1947. They used the premises as a social hall until 1974 when the City of Middletown purchased it. In a series of twentieth century remodellings, the balustrade and cupola were removed and the interior was modernized. Paneling and partitions were erected, floors tiled, ceilings lowered, and door hardware replaced.

In recent years the Mather-Douglas House, owned by the City of Middletown, has stood vacant and suffered from neglect. Present city plans call for adaptive use and restoration.
