HISTORIC RESOURCES INVENTORY FORM
For Buildings and Structures

1. BUILDING NAME: Common: deKoven House Historic: Clarence Wadsworth House; Benjamin Williams House

3. STREET & NUMBER (and/or location): 27 Washington Street

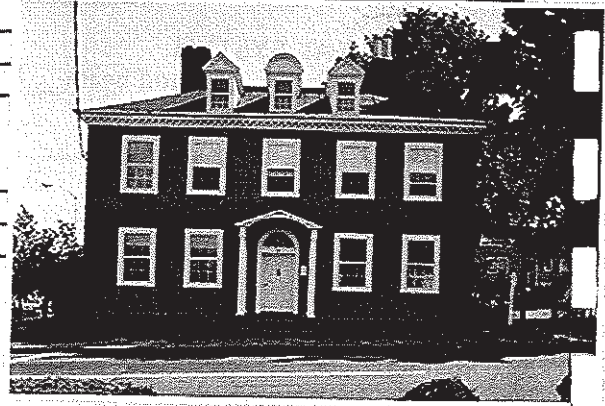
photographer: Robert Svec
date: 9/78 view: north
negative on file: Roll 31, #21

The building was designed in the late Georgian style. The symmetrically arranged facade displays three dormers that project from the truncated, hipped roof. The middle dormer has a semicircular gable which contrasts with the pediments of the other two. The roof is bordered by mutules and dentils. An Adamesque porch, probably added in the early 1800s, is characterized by slender columns and a thin, curved ceiling. It frames the main entrance which has a semicircular fanlight above the door. Brownstone quoins (see continuation sheet)

accent the building's brick walls; the facade and east elevation are laid in the decorative Flemish bond. The interior displaying a central hall plan, also retains much of its original detail. The stairway exhibits thick balusters; the walls are wood paneled; and wide, crown mouldings decorate the rooms. Antique furnishings contribute to the early appearance of two rooms on the first floor, open to the public.
