HISTORIC RESOURCES INVENTORY FORM  
For Buildings and Structures

- 1. BUILDING NAME: Common: \_\_\_\_\_ Historic: Tollgate House
- 2. TOWN/CITY: Middletown VILLAGE: \_\_\_\_\_ COUNTY: Middlesex
- 3. STREET & NUMBER (and/or location): Brooks Road, southeast corner of intersection with Tollgate Rd
- 4. OWNER(S): Jerome and Carolee Gibbons PUBLIC  PRIVATE
- 5. USE: Present: Residence Historic: Tollhouse for Middlesex Turnpike Road
- 6. ACCESSIBILITY TO PUBLIC: Exterior visible from public road:  yes  no  
Interior accessible:  yes, explain \_\_\_\_\_  no

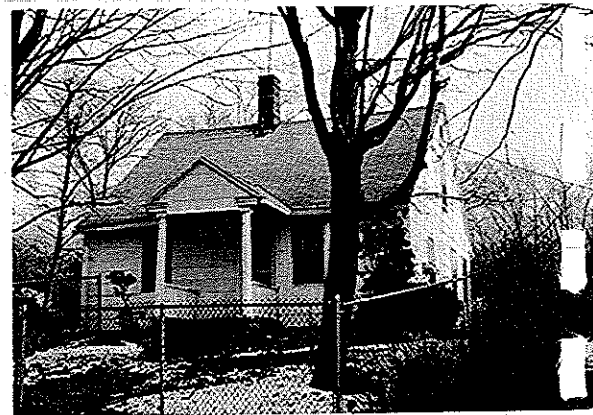
photographer: Robert Svec  
date: 12/78 view: west  
negative on file: Roll 52, #9A

The structure has a three-bay facade with the entrance slightly off-center. The narrow central chimney is also positioned off to one side. Early cornice mouldings border the broad gabled roof. A small shed roofed addition is at the rear. The prominent front porch supported by plain columns, is a later addition.
