HISTORIC RESOURCES INVENTORY FORM

1. BUILDING NAME: Common: Hose Co. #2 Historic: Payne's Music House
2. TOWN/CITY: Middletown VILLAGE: _____ COUNTY: Middlesex
3. STREET & NUMBER (and/or location): 107 College Street
4. OWNER(S): City of Middletown PUBLIC PRIVATE
5. USE: Present: Vacant Historic: Firehouse; Music store
6. ACCESSIBILITY TO PUBLIC: Exterior visible from public road: yes no
Interior accessible: yes, explain permission of Redevelopment Agency no

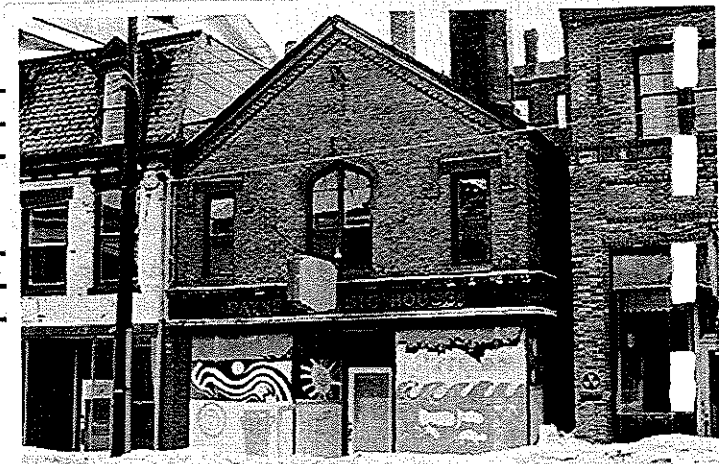
PHOTOGRAPH

Shouldered brick window caps on outer windows of second floor facade
Gothic-arched windows, second floor center
Stepped brick work under cornice
Hose-drying tower

photographer: Elizabeth Loomis
date: 2/78 view: north
negative on file: Roll 15, #35
