HISTORIC RESOURCES INVENTORY FORM

- 1. BUILDING NAME: Common: Orange Judd Hall Historic: same
- 2. TOWN/CITY: Middletown VILLAGE: \_\_\_\_\_ COUNTY: Middlesex
- 3. STREET & NUMBER (and/or location): High St. (College Row, between Church and Washington)
- 4. OWNER(S): Wesleyan University PUBLIC  PRIVATE
- 5. USE: Present: Educational Historic: same
- 6. ACCESSIBILITY TO PUBLIC: Exterior visible from public road:  yes  no  
Interior accessible:  yes, explain classrooms  no

Orange Judd Hall  
High Street (College Row), Middletown, Ct 06457

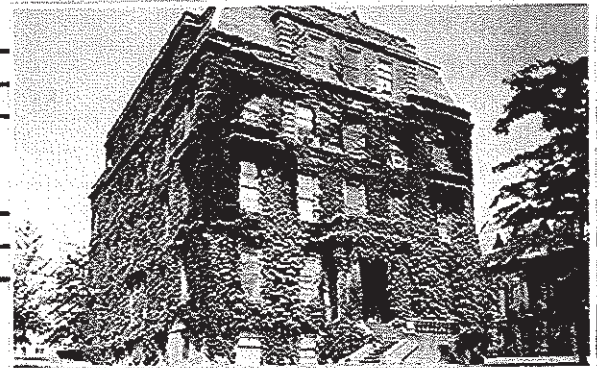
PHOTOGRAPH

- 11. NUMBER OF STORIES: 3 1/2 APPROXIMATE DIMENSIONS: 95'x63'
- 12. CONDITION: Structural:  excellent  good  fair  deteriorated  
Exterior:  excellent  good  fair  deteriorated

In 1957-58 the interior and roof were completely reconstructed. The dormers and chimneys were removed, and the roof altered so that at present only the corners of the roof reveal its mansard configuration.

photographer: John E. Reynolds  
date: 7/78 view: southeast  
negative on file: Roll 29, 35A-36
